**PUBLIC ARTWORK ASSESSMENT
PALO ALTO, CALIFORNIA**

Condition Assessment and Recommendations for Selected Artworks

Prepared for:
City of Palo Alto

Prepared by:
ARG Conservation Services, Inc.
San Francisco, California

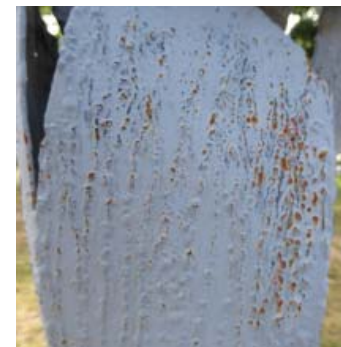
- Sited within an open lawn area.
- Spotlight within 5 ft of front.
- Near in-ground sprinkler. Water spray hits figure right at hip line, contributing to paint loss/ abrasion and preferential corrosion.

Detail of paint loss and corrosion at back of leg.

- Clean all surfaces with a pH neutral conservation-grade detergent.
- Reinforce broken weld at arm and welds at feet with epoxy resin.
- Perform in-painting to visually integrate losses.
- Test effectiveness and apply cold paste wax coating at painted surfaces.
- Identify original coatings if possible, and consider stripping and repainting.

- Modify sprinkler system (relocate, redirect or change head type) to avoid the sculpture.
- Remove accumulated debris when found.
- Perform overall cleaning with conservation-grade detergent, and renew wax coating (if applicable) on annual basis.
- Monitor for corrosion-related damage.

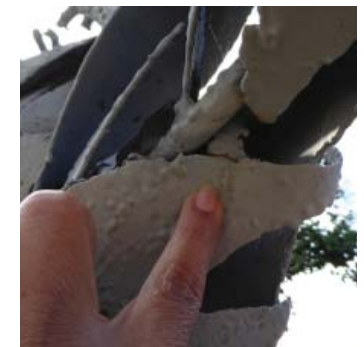
Detail of broken weld under proper left arm.

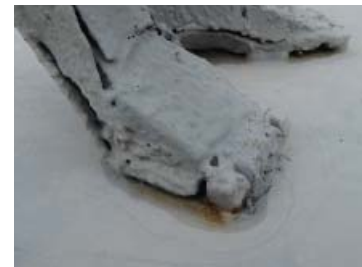
View of top of podium and feet.
Note surface water, tide lines, and
corrosion at welds.

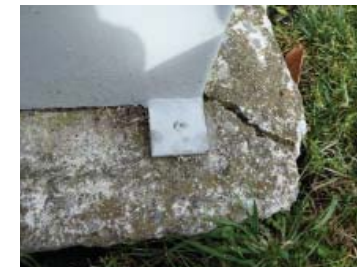
- Concrete surfaces deteriorated; soiling, bio growth present.
- Cracks at three out of four corners.
- Missing bolt fastener at front right corner.

Detail of damage at concrete
pad.

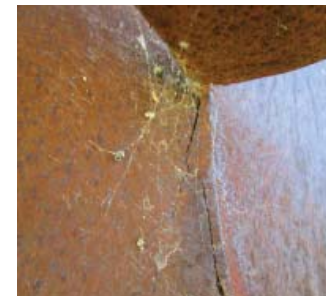
Detail of structural crack at front side (reverse side sim.)

- Reinforce structural cracks with epoxy resin.
- Rinse surfaces with distilled water to remove surface soiling and debris.
- Remove additional grime/ guano in localized areas with swabs.
- At areas where patina has been disrupted, treat with dilute acid solution to accelerate formation of new oxide layer.

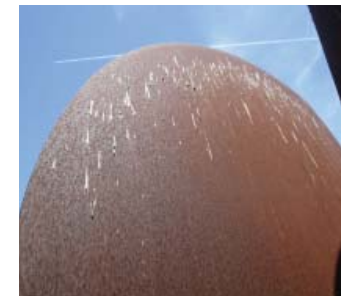
Detail of bird guano at top of disc form.

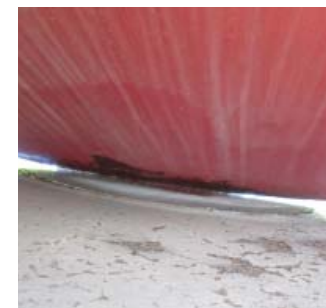
- Sited within an open lawn area.
- Sprinklers located near sculpture. Surface water observed at base, contributing to corrosion-related damage.
- Spotlights located within 20 ft of sculpture.

Detail of welded connection at base of tubular grid. Note heavy corrosion and staining/drip marks.

- Overall cleaning with low-pressure water spray.
- Inspect welded connections and repair as necessary.
- Chemically stabilize areas of corrosion at steel inserts.
- Apply a protective paint coating at inserts.

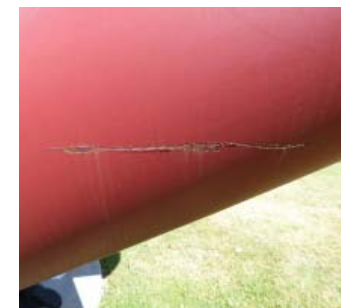
Detail of gouge at front of tube. Note peeling paint and corrosion.

- Clean all surfaces with a pH neutral conservation-grade detergent.
- Chemically stabilize areas of corrosion.
- Fill deep gouges with a compatible filler, based on conservator testing.
- Perform in-painting to visually integrate losses.
- Test effectiveness and apply clear paste wax or protective compounding wax.

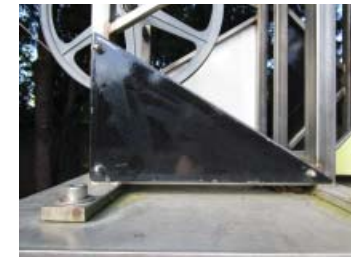
Detail of surface marring at black panel.

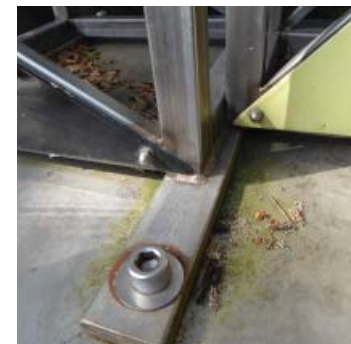
Detail of corrosion, debris and bio growth at metal base.

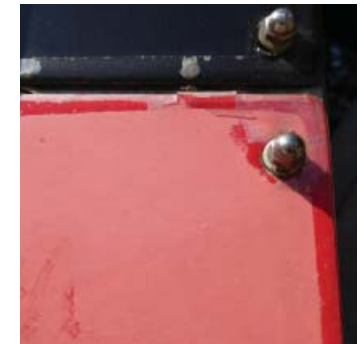
- Stable structural condition.
- Porcelain enamel panels have edge coating failure, typical throughout. This may be a pigmented lacquer coating, common among conservators for retouching porcelain objects, and among porcelain enamel sign manufacturers for repairing defects.

Detail of coating failure at edge of porcelain enamel. Also note color fade.

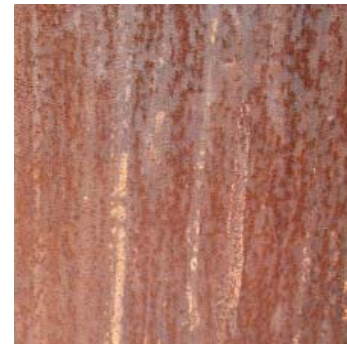
Detail of streaks in patina, most likely due to prior cleaning.

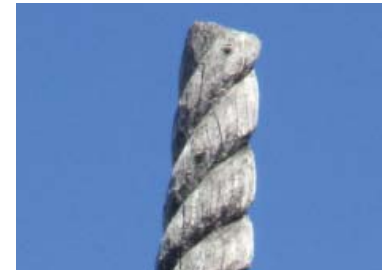
Detail of weathering at top of pole.

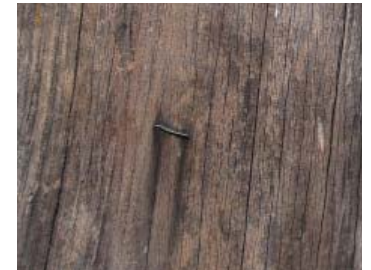
Detail of staple and ferrous staining at wood.

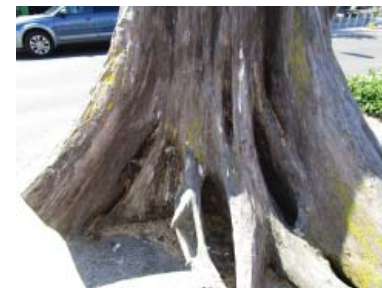
Detail of base of tree. Note debris and bio-growth.

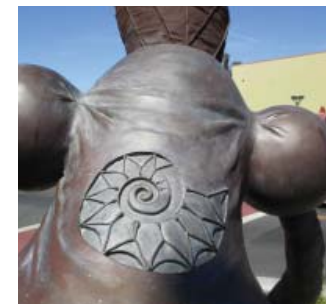
Detail of doll's back. Note blanching wax coating.

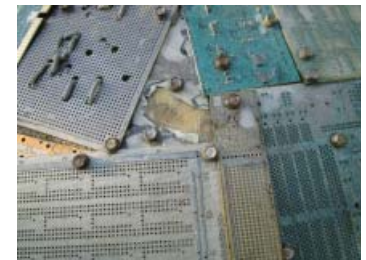
Detail of circuit boards. Note exposed fiberglass, coating failure and mild corrosion at fasteners.

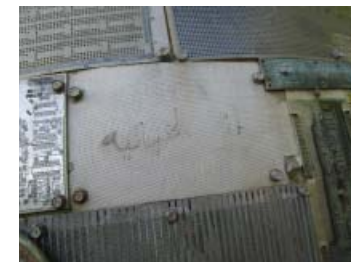
Photo comparison of circuit board. Above photo from artist's website, below is current condition.

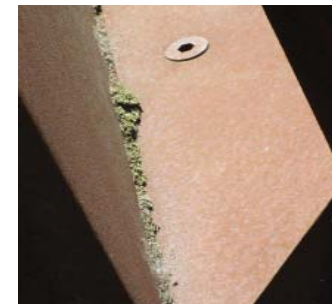
Detail of biological growth at weathering steel.

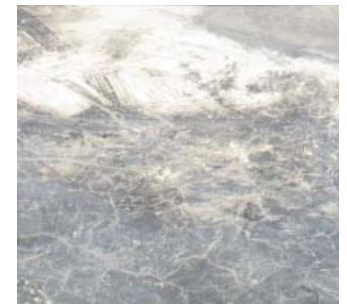
Detail of paint loss and patch repairs at base.

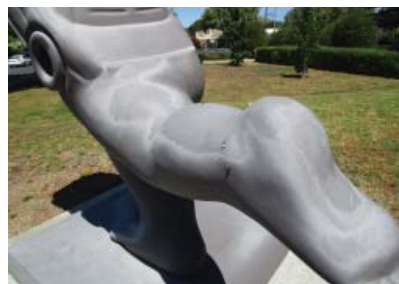
Detail of photochemical degradation on top of leg.

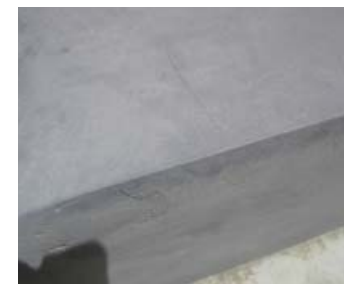
Detail of crack in side of fiberglass base.

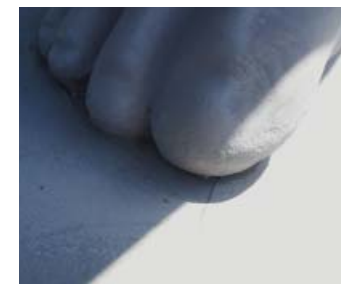
Detail of crack in fiberglass base near toes.

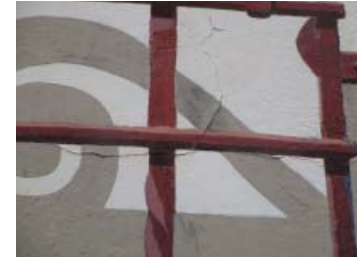
Detail of paint cracking at window grate.

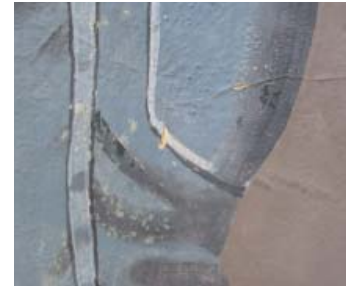
Detail of paint loss at pants. Note prior green color below.

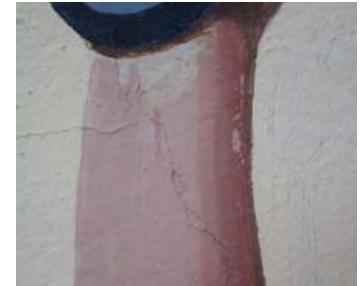
Detail of paint loss and cracking at proper right arm.

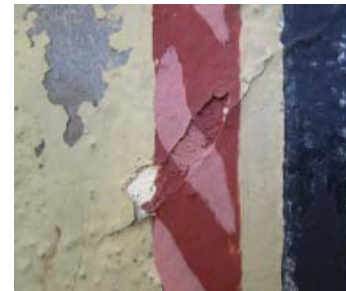
Detail of paint loss and previous in-painting.

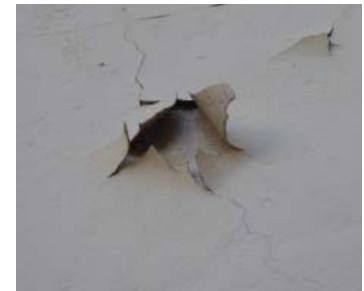
Detail of flaking and cracking paint at stucco wall.

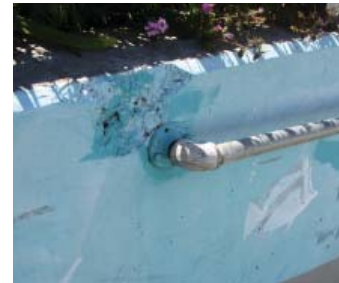
Detail of concrete spall at outdoor wall. Also note railing.

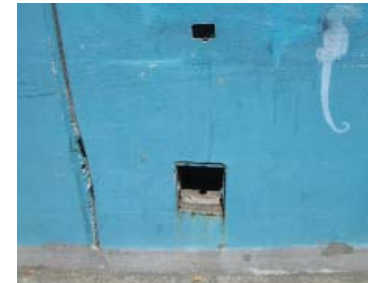
Detail of outdoor wall. Note missing grilles and deteriorated expansion joint
