Cross-Bore Program Update: Phase 2

Utilities Advisory Commission

June 1, 2016

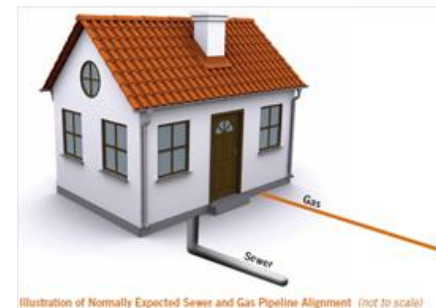
Illustration of Normally Expected Sewer and Gas Pipeline Alignment (not to scale)

Ideal condition

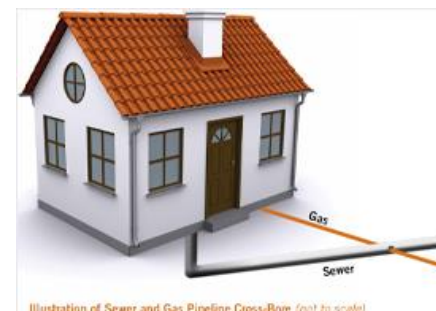
Illustration of Sewer and Gas Pipeline Cross-Bore (not to scale)

Crossbore

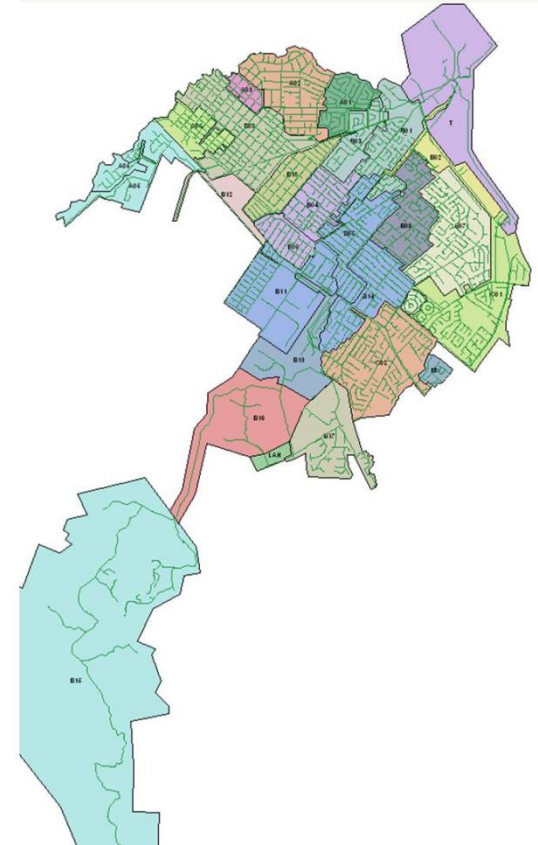
Collection System Basins

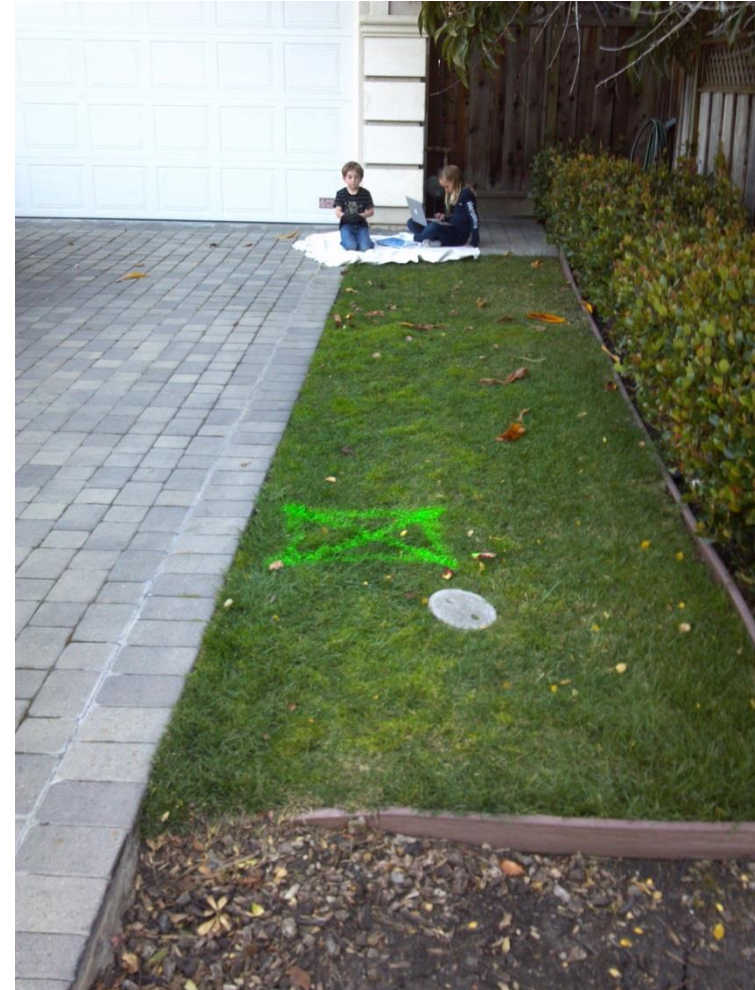
*Example of
infrastructure location
in cross-bore*
