# Redwood Tree Monitoring Study 2009–2016

## Introduction

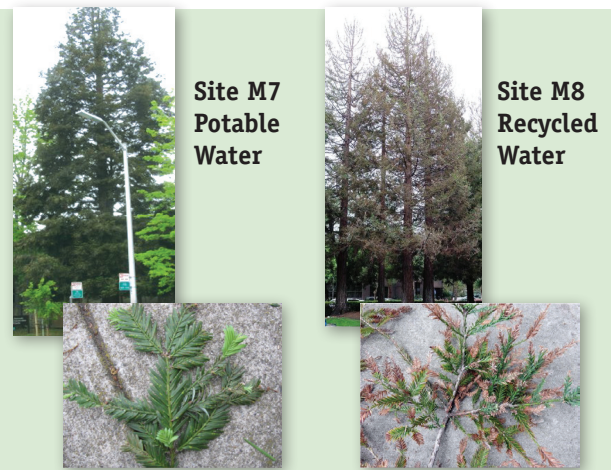
During the study period soil salinity (measured as electrical conductivity, EC) at sites irrigated with recycled water increased and, in most cases, exceeded the maximum threshold for redwoods. Soil salinity remained below the threshold at all sites irrigated with potable water. The sodium adsorption ratio (SAR) measured in soils from recycled water sites also exceeded the maximum threshold for redwoods, indicating an imbalance of certain elements (more sodium, less calcium and magnesium).

A high SAR value is correlated with soil drainage problems and limits the ability to leach salts from soil. Landscape managers typically address this problem by applying gypsum before the rainy season to reduce the SAR and move sodium below the tree roots. This adaptive management strategy was applied at two sites in the winters of 2012-2014. While these actions reduced soil salinity, there was inadequate rainfall for the treatment to be fully effective.

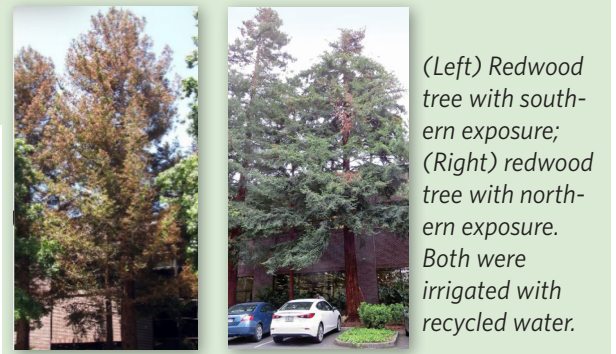
Trees located on the north or east side of the site exhibited fewer symptoms of decline than those located on the south or west side. This difference is assumed to be due to sun and wind exposure increasing evapotranspiration rates and thus increasing the volume of water (and salt) absorbed by each tree. Salt concentrations were also higher in dry, water stressed foliage than in well hydrated foliage.

(Left) Redwood tree with southern exposure; (Right) redwood tree with northern exposure. Both were irrigated with recycled water.

- Trees in high exposure microclimates (i.e., south or west-facing) were more impacted than those in shaded, protected areas.
- Efforts to reduce the RWQCP's recycled water salinity were insufficient to reach the 600ppm TDS goal.
