**600 Clyde Avenue
Avian Collision Monitoring Final Summary Report
October 2020–April 2022**

Project #3475-43

H. T. Harvey & Associates

August 30, 2022

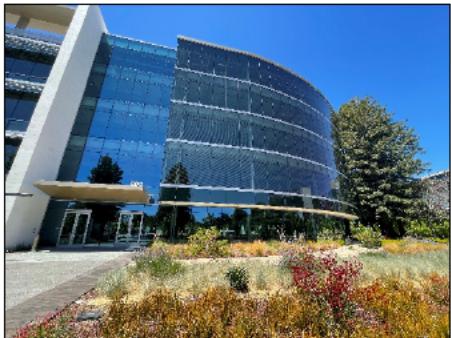
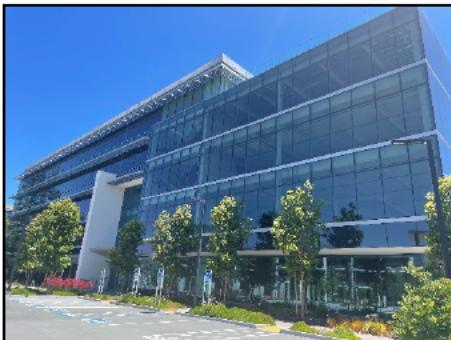
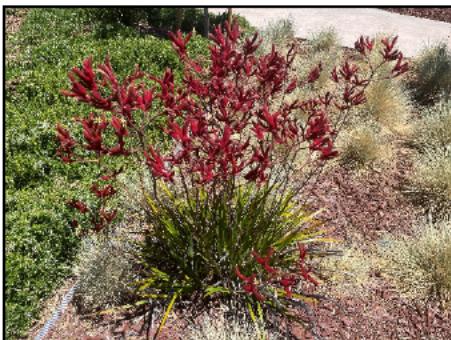
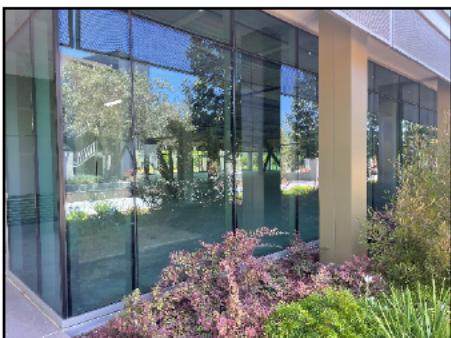
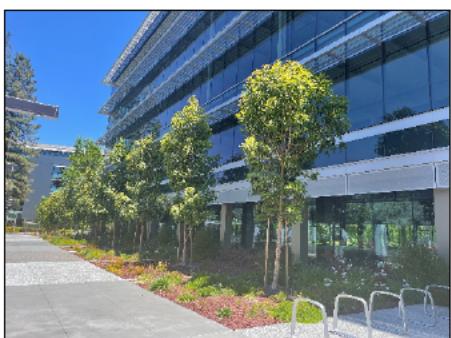
Of the 104 incidents of collisions recorded during the monitoring, 58 included evidence on glass (53 observed instances of feathers on glass, 5 observed instances of imprints on glass). Because the 600 Clyde office building includes some areas that are treated with a bird-safe glazing treatment, when collision evidence was detected on glass we noted if the glass was treated with a bird-safe glazing treatment. Of the 53 collisions for which evidence was detected on glass, 52 occurred on untreated glass and 1 occurred on bird-safe glass (Figures 2–5).

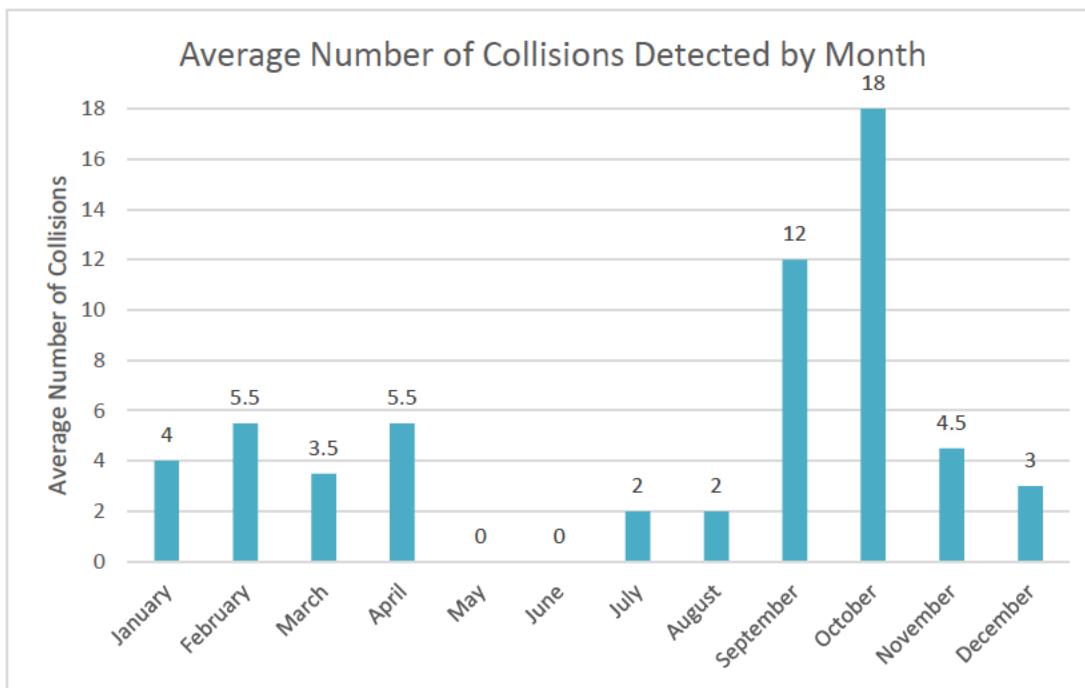
A summary of the average number of collisions detected by month during the monitoring period is provided in Figure 1 below. The frequency of detected collision incidents varied throughout the year, with the highest average number of collisions occurring in September (12 per month) and October (18 per month) during the fall migration season. Lower numbers of collisions (3–5.5 per month) occurred during the winter and spring migration periods from November to April, with the lowest numbers of collisions (0–2 per month) occurring during the summer breeding season from May to August.

Figure 1. The average number of collisions detected by month throughout the monitoring period.

We reviewed the monitoring data to determine if the observed collision rate with the 600 Clyde office building is demonstrably higher than that of another building in a similar setting. During the monitoring period, we detected evidence of 104 collisions with the 600 Clyde office building. Average collision rates by month are shown on Figure 1.

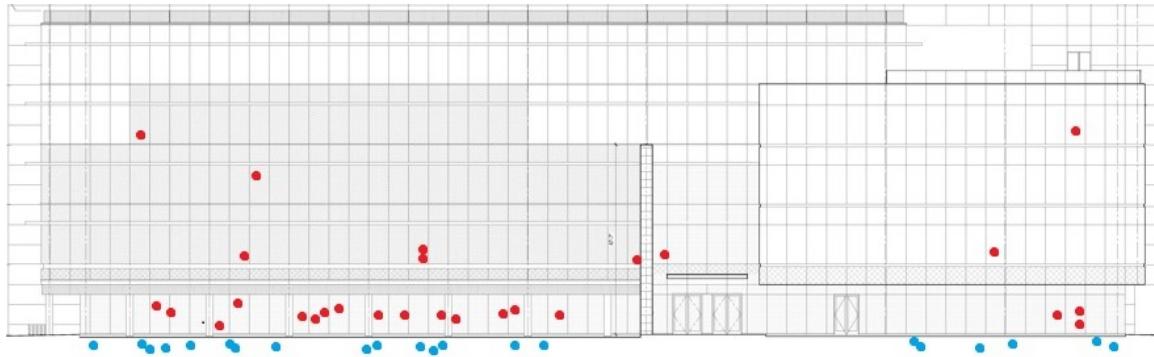
Figure 2. Evidence of 48 collisions was detected with the west façade, including 27 locations on glazing (indicated as red points) and 21 locations on the ground next to the façade (indicated as blue points).

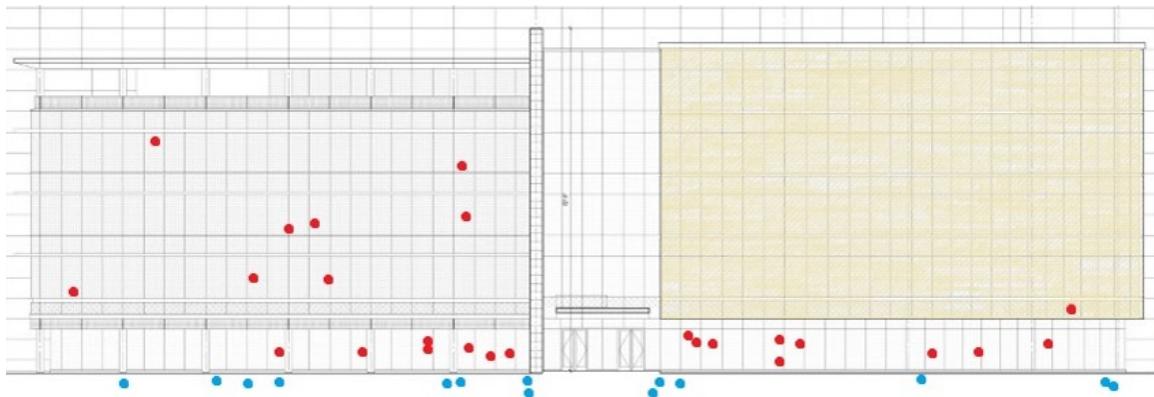
Figure 3. Evidence of 39 collisions was detected with the east façade, including 25 locations on glazing (indicated as red points) and 14 locations on the ground next to the façade (indicated as blue points). Bird-safe glass is indicated in yellow.

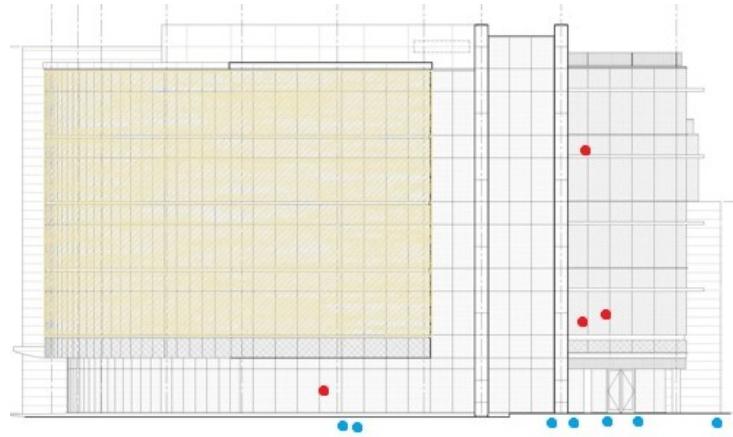
Figure 4. Evidence of 11 collisions was detected with the north façade, including four locations on glazing (indicated as red points) and seven locations on the ground next to the façade (indicated as blue points). Bird-safe glass is indicated in yellow.

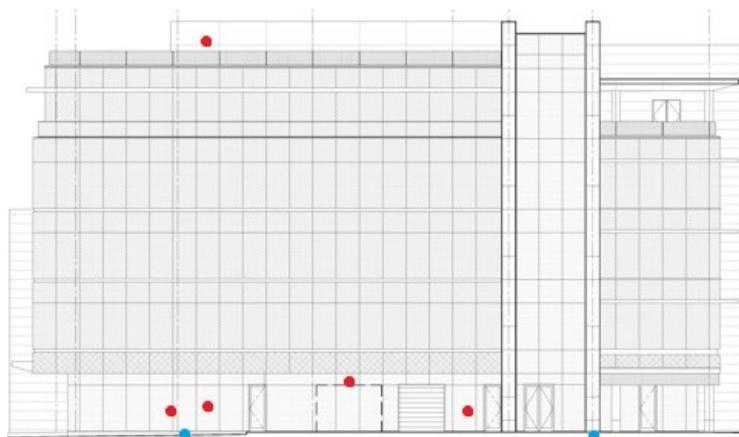
Figure 5. Evidence of seven collisions was detected with the south façade, including five locations on glazing (indicated as red points) and two locations on the ground next to the façade (indicated as blue points).
