Historic Resources Board Staff Report

261 Hamilton Avenue: Review and Recommendation of a Request to Update a Property's Individual Palo Alto Historic Inventory Category to Category 2 from Category 3; the Property is Located in the National Register Ramona Street Architectural District

REGARDING 261 Hamilton Avenue – Palo Alto Historic Inventory Evaluation Memorandum

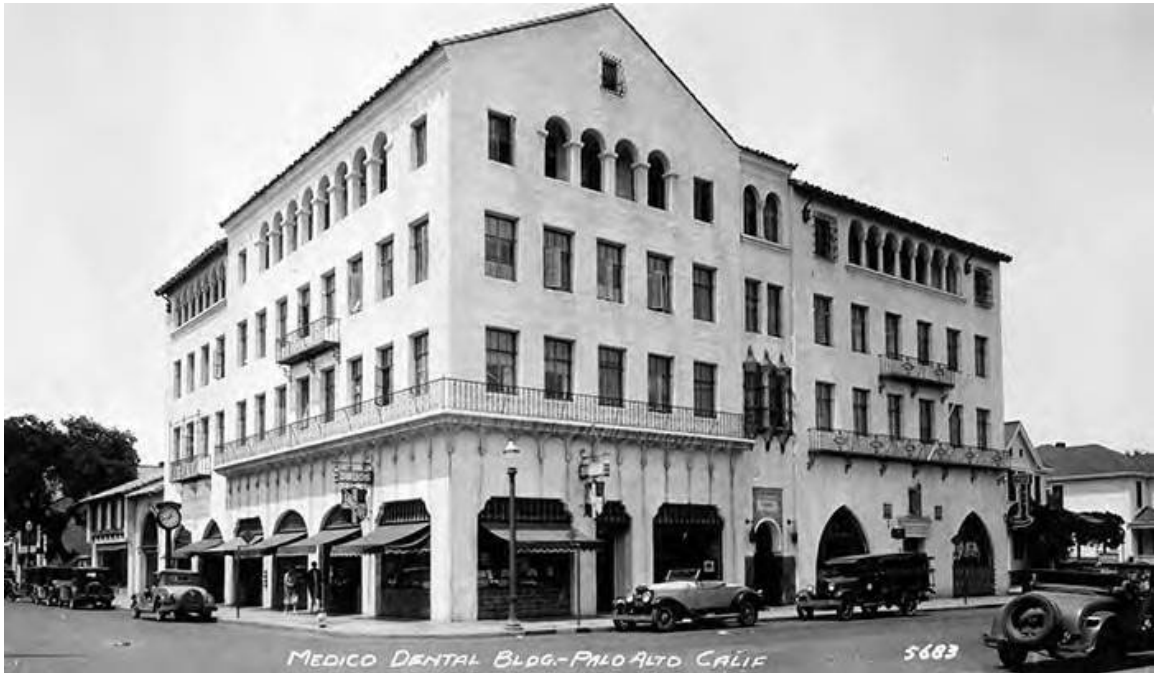
Figure 2. Subject building, c.1928. Source: Palo Alto Historical Association.

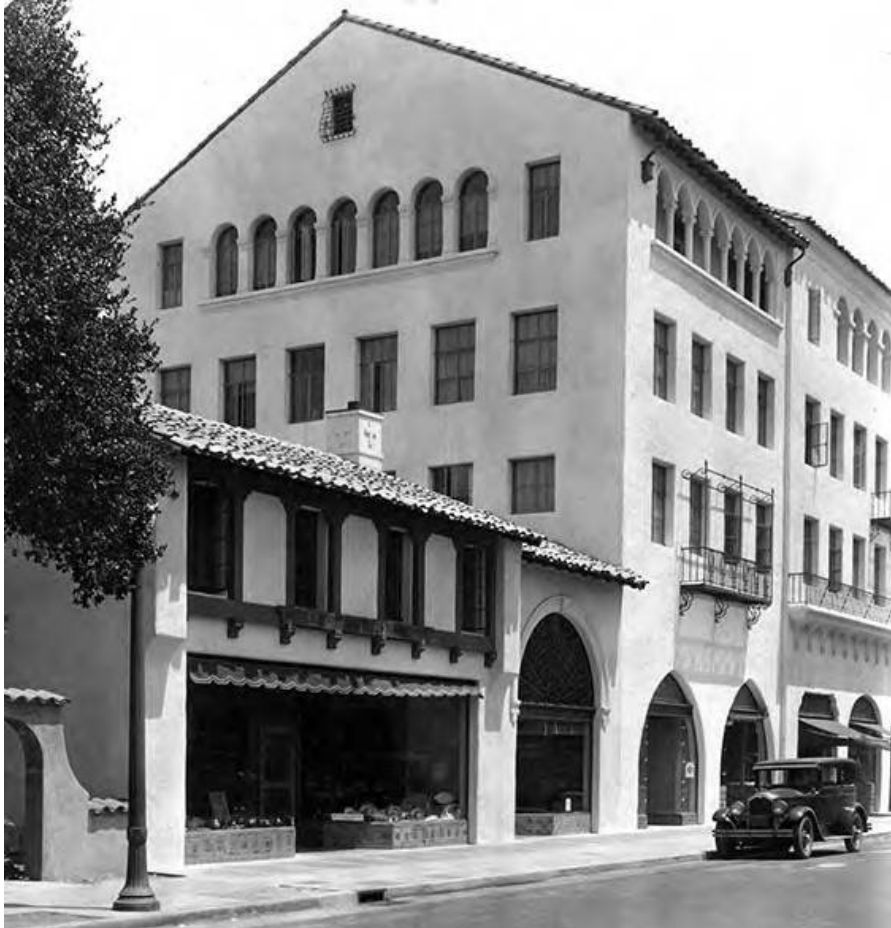
Figure 3. View of the west and south facades of the subject building from Ramona Street, c.1928. Source: Palo Alto Historical Association.

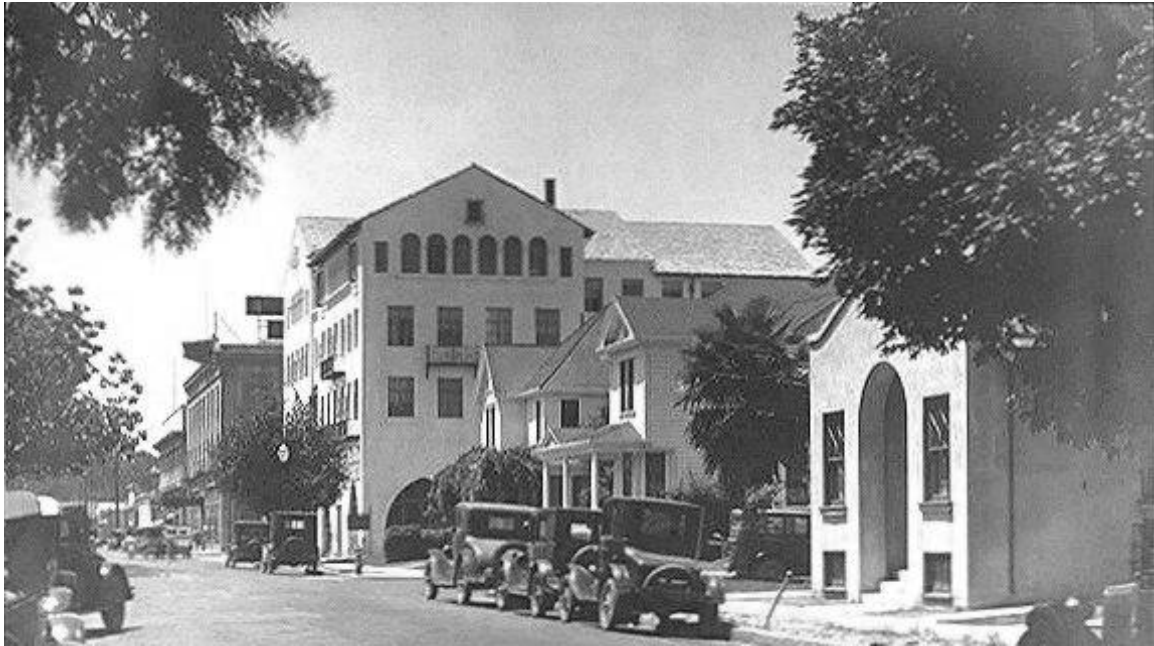
Figure 4. Context view of the north and east façades of the subject building, viewed from Hamilton Avenue c.1928. Source: Palo Alto Historical Association.

In photographs from 1928 to the early 1930s, parts of the north and east facades are visible from Hamilton Avenue. In both photographs, two wood frame residences that originally neighbored the subject building can also be seen at center prior to their demolition (**Figure 4** **Figure 5**).

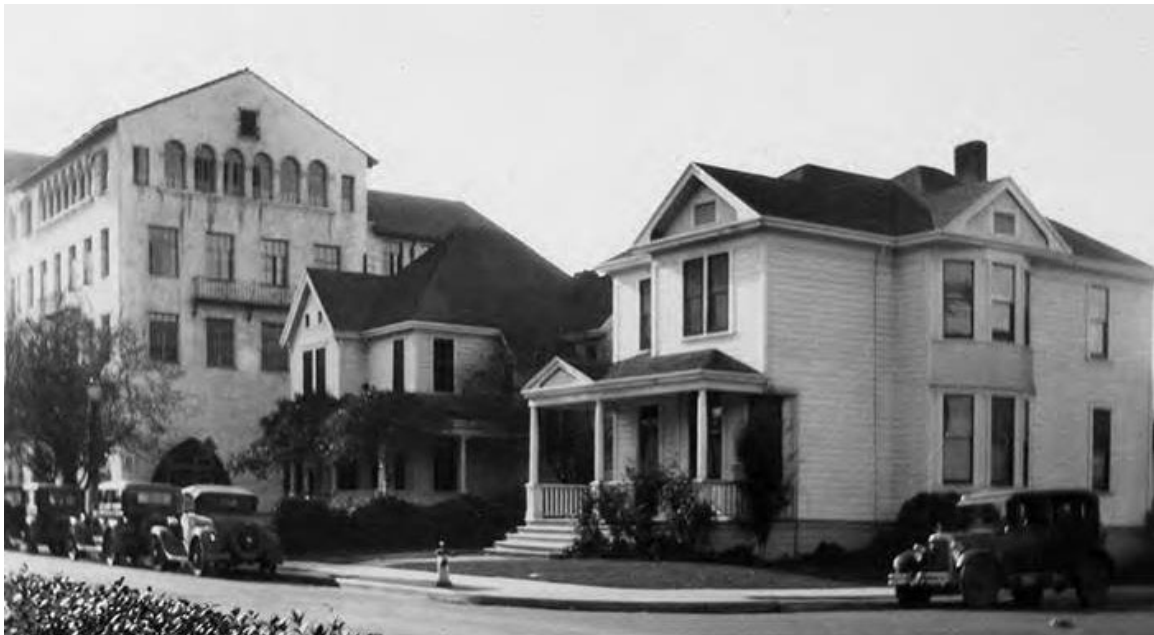
Figure 5. Context view of the north façade and upper levels of the east façade of the subject building, viewed from Hamilton Avenue c.1930s. Source: Palo Alto Historical Association.

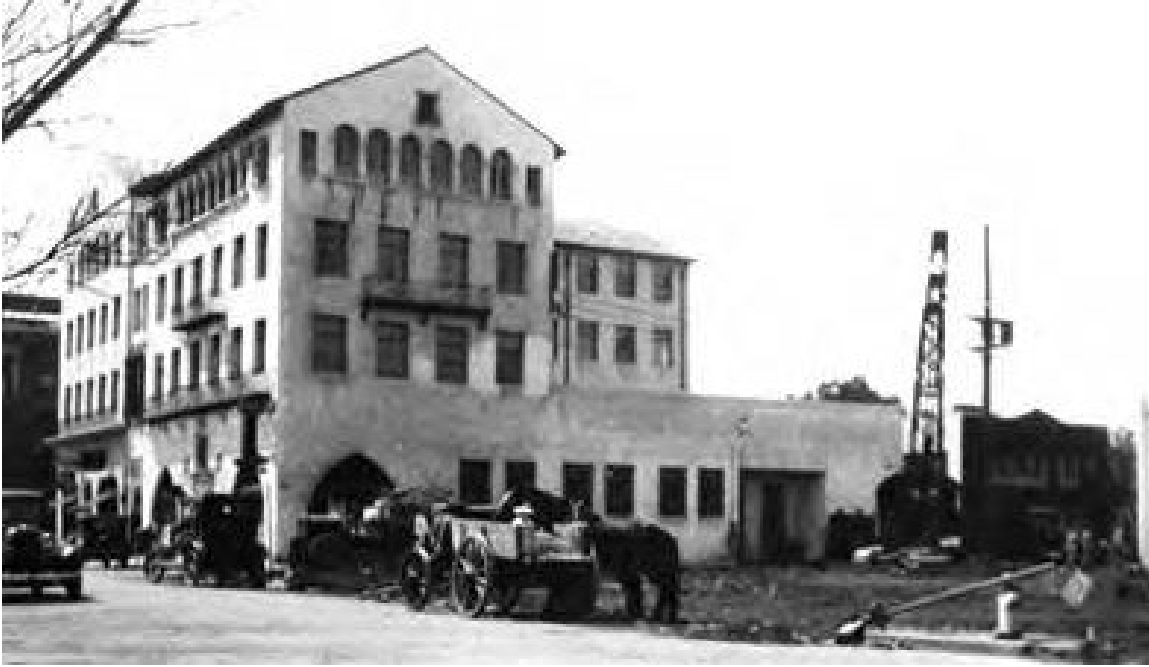
Figure 6. Context view of the north and east façades of the subject building, viewed from Hamilton Avenue, c.1930s. Source: Palo Alto Historical Association.

A photograph likely dating to the later 1930s and taken from a similar angle along Hamilton Avenue and to the southwest shows the demolition of the two frame residences neighboring the subject

property (**Figure 6**). From this angle, most of the north façade is visible, including the original fenestration pattern at the ground floor.

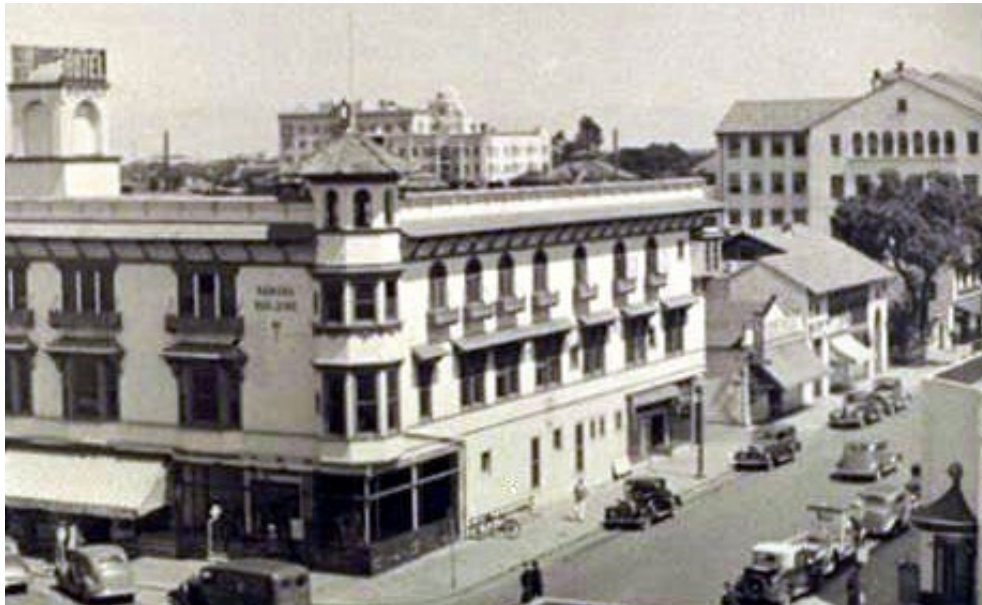
Figure 7. View of Ramona Street and the former Ramona Hotel, with the west façade of the subject building visible in the background at right, 1937. Source: Palo Alto Historical Association.

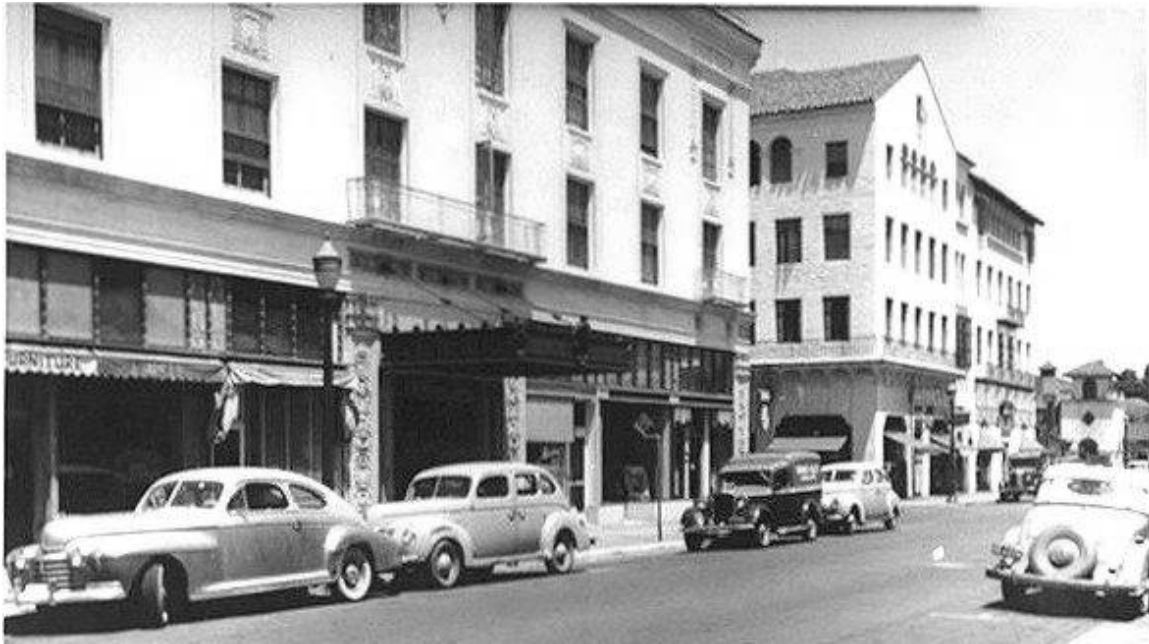
Figure 8. View of Hamilton Avenue with the south and east facades of the subject building visible in the background at right, c.1944. Source: Palo Alto Historical Association.

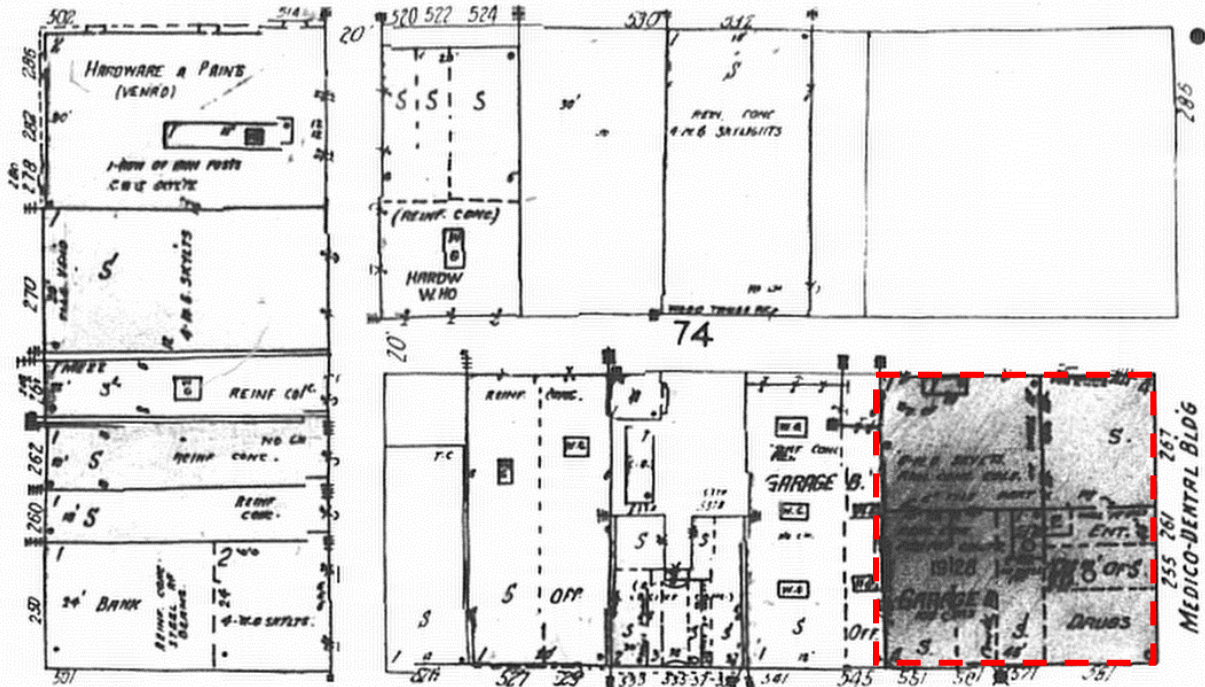
Figure 9: Sanborn Map Company fire insurance map of Palo Alto, 1947. Page 4. The subject property is outlined in red. Source: Historical Information Gatherers. Edited by Page & Turnbull.

A Sanborn insurance map from 1947 notes the “Garage” located in the basement level, which was a somewhat advanced structural and social feature at the time of the building’s construction (**Figure 9**). The map also notes a drugstore, office, and other stores on the ground floor along with an upper floor lobby with elevator. The map confirms that the subject building’s footprint has remained unchanged over time.

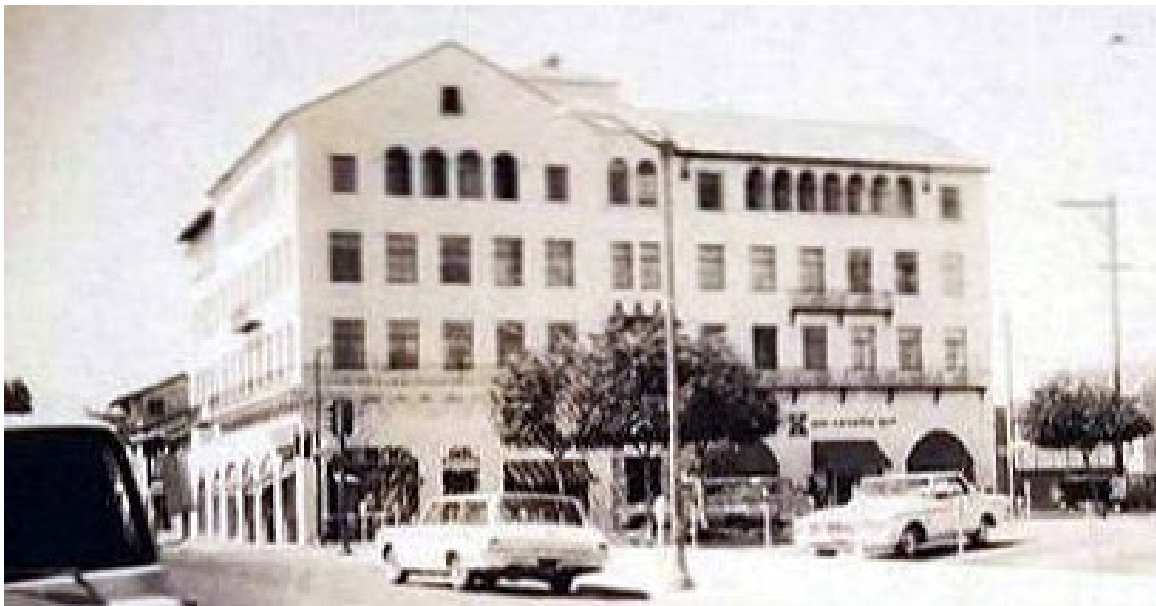
Figure 10. Context view of the south and east facades at the corner of Ramona Street and Hamilton Avenue, c. early 1960s. Source: Palo Alto Historical Association.

Permit records from 1965 indicate that there were alterations and a remodeling of storefront windows.⁶ This information is corroborated by a photograph likely dating to the early 1960s, which shows rounded and square awnings added to two of the storefront windows along with new signage in the place of the original Post Office tilework.⁷ From visual analysis, it appears that hanging retail signs were also removed during the period, however the remaining windows on the ground floor appear to have retained their original awnings and storefront configurations (**Figure 10**).

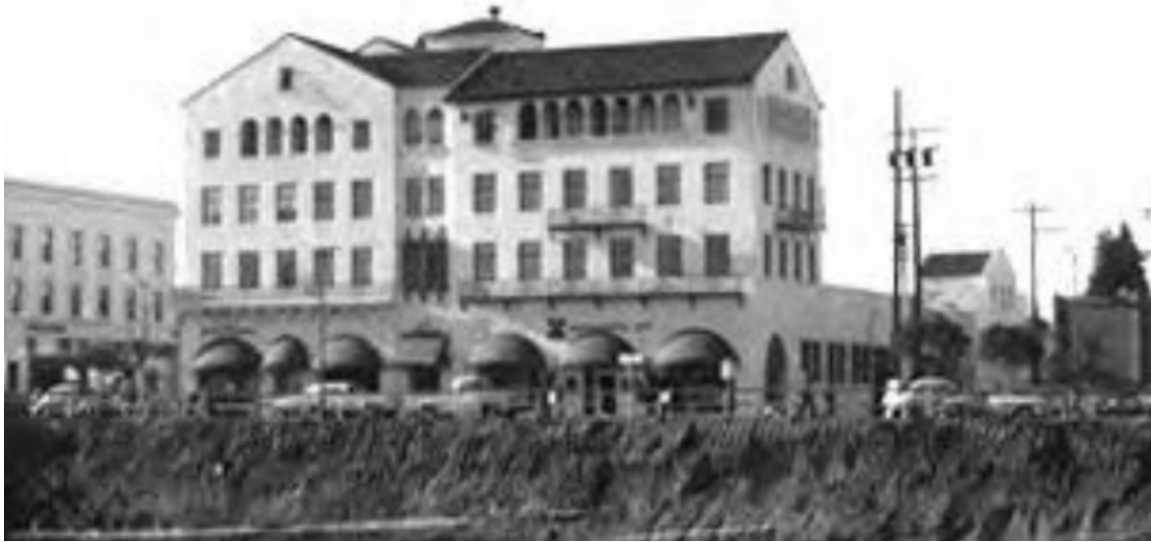
Figure 11. Context view of the east and north facades from across the construction site of the future City Hall building and plaza, 1967. Source: Palo Alto Historical Association.

A photograph from 1967 shows that the remaining storefront windows were altered and replaced with more rounded awnings in the intervening two years (**Figure 11**). It also appears that the north façade facing the alleyway retained the original fenestration pattern shown in earlier photographs dating to the 1930s.

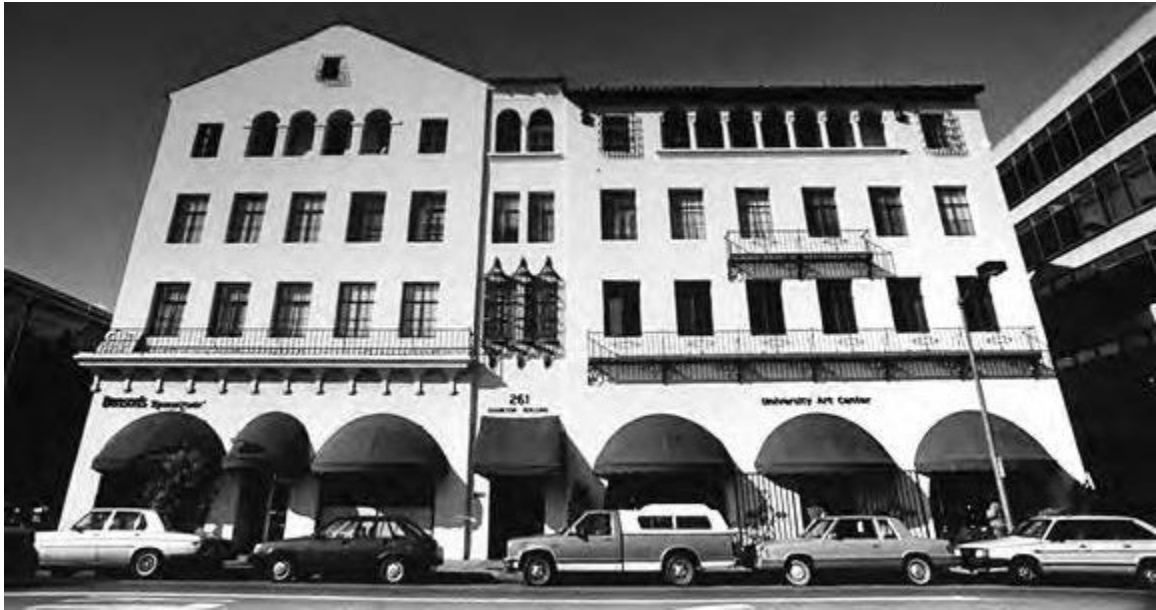
Figure 12. View of the east façade of the subject building along Hamilton Avenue, 1986. Source: Palo Alto Historical Association.

Photographs dating in range from 1986 to 1994 show that the east façade remained mostly unaltered beyond further changes to the storefront systems at the ground floor of Hamilton Avenue, which included the addition of a new metal grate at the central northern storefront (**Figure 12 and Figure 13**).

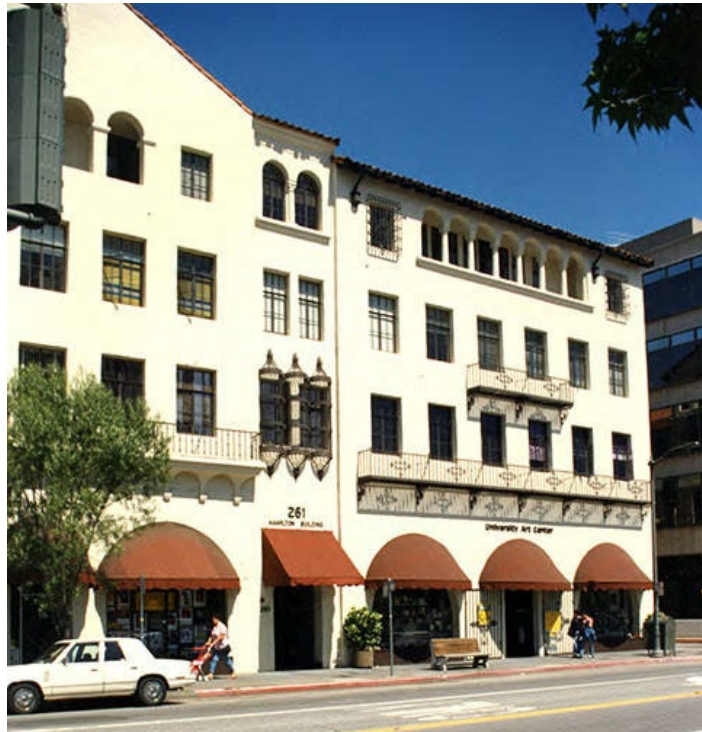
Figure 13. View of the east façade of the subject building along Hamilton Avenue, 1994. Source: Palo Alto Historical Association.

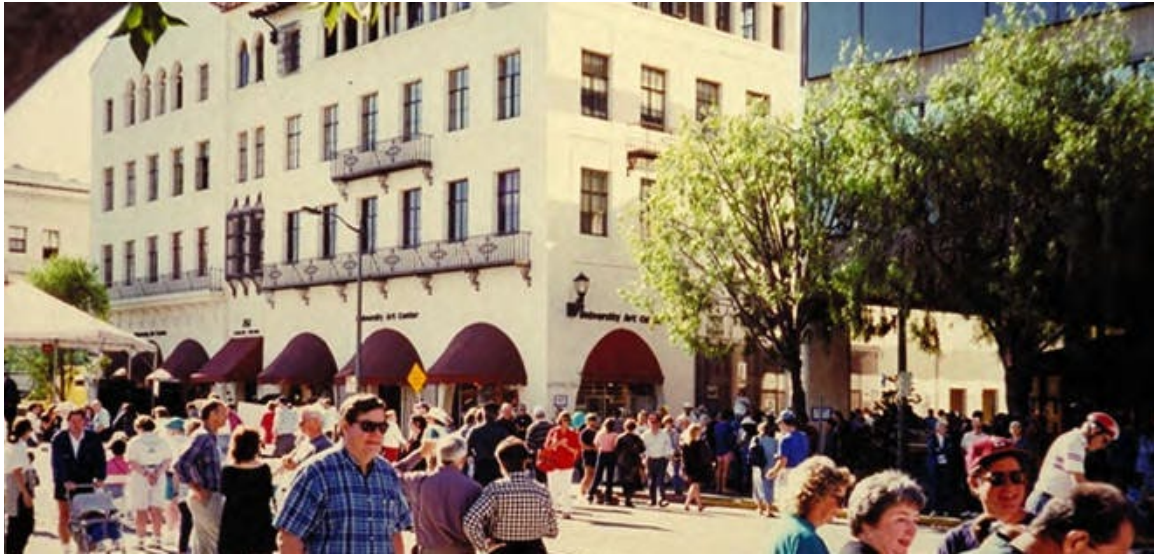
Figure 14. Context view of the north and east facades of the subject building, viewed from Hamilton Avenue, April 1994. Source: Palo Alto Historical Association.

Photographs dating from April to May 1994 show alterations to the fenestration of the north façade, which faces the alleyway, including what appears to have been the removal or enclosure of six windows with stucco (**Figure 14, Figure 15, and Figure 16**).

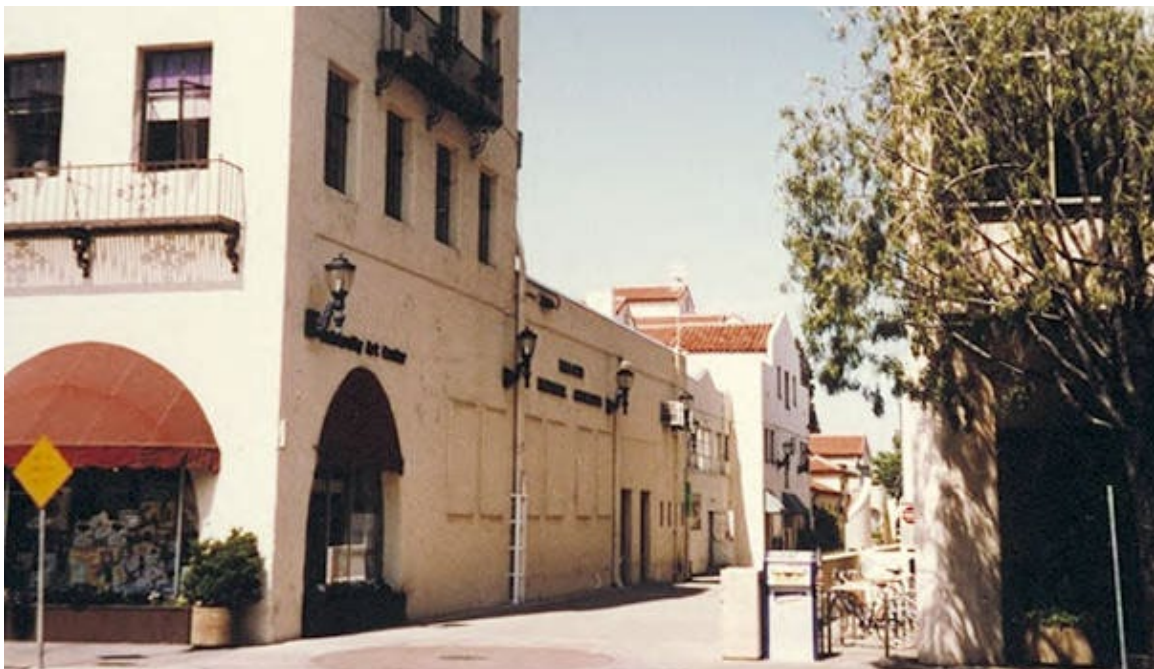
Figure 15. View of the north façade facing Centennial Walk, viewed from Hamilton Avenue, May 1994. Source: Palo Alto Historical Association.

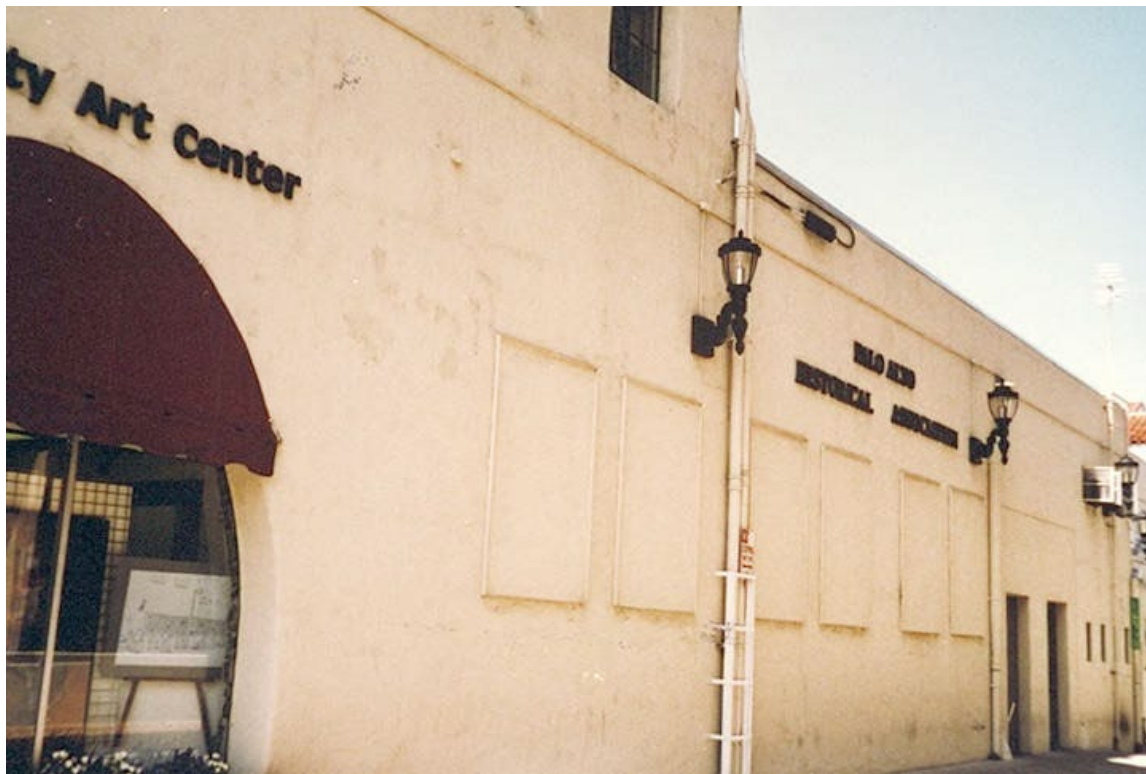
Figure 16. View of the north façade facing Centennial Walk, 1994. Source: Palo Alto Historical Association.
