**CITY of PALO ALTO, CALIFORNIA**

**WILLIAMS HOUSE  
MUSEUM OF AMERICAN HERITAGE**

**ADA TRANSITION PLAN UPDATE**

**Re: MUSEUM OF AMERICAN HERITAGE (WILLIAMS HOUSE) – ADA TRANSITION PLAN UPDATE**

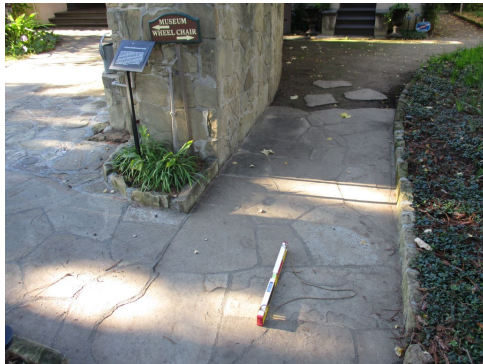
A junction between the pathways is shown in the photo at left. The signage provided indicated that the pathway on the left leads to the museum, and on the right, the pathway is intended for wheelchair use, but that pathway ends in dirt and separated paver stones that a person using a mobility assist device could not access. First of all, the sign is required to have an ISA symbol if it is indicating an accessible route. Second, the path to the museum is not accessible, which leaves the path indicated as the only accessible route to all amenities located on the site. In addition, this location serves as a landing where people must turn and make a change of direction to continue to the small alcove in the front of the building where children’s performances are held. The pedestrian path to the area was also identified with a non-compliant cross slope.

The photo also illustrates the fact that the path indicated as an accessible route changes from a paved path to a dirt path where single stepping stones create obstacles for wheelchair users and potential trip hazards for other pedestrians. In fact, the transition between the paver stones and dirt path was identified with a 1” abrupt change in level that could prevent travel for people using

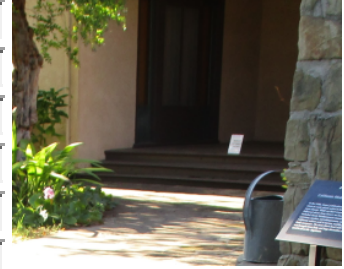
Field Date:	<input type="text" value="12/2/2016"/>	Report Date:	<input type="text" value="1/6/2017"/>	Barrier #:	<input type="text" value="7A"/>
Facility:	<input type="text" value="Williams House - Museum of American Heritage"/>				
Location:	<input type="text" value="Walkway - Performance Area"/>				
Official Responsible:	<input type="text" value="City of Palo Alto"/>				
Facility Function:	<input type="text" value="Public"/>	Dwg:	<input type="text" value="1 of 3"/>		
Barrier Area:	<input type="text" value="Stairways"/>	Remediation:	<input type="text" value="Required"/>		
Barrier Type:	<input type="text" value="Handrail - Both Sides"/>				
Barrier Description:	<input type="text" value="No handrail provided at both sides of stairway"/>				
Code References:	<input type="text" value="CBC 11B-505.2 and 2010 ADAS 505.10.2"/>				
As Built Description:	<input type="text" value="No handrail provided at both sides"/>

Proposed Solution:	<input type="text" value="Provide handrails at both sides of stairway"/>				
As-Built Meas:	<input type="text" value="4"/>	Quantity:	<input type="text" value="LF"/>	Cost Estimate:	<input type="text" value="\$900.00"/>
				BSR:	<input type="text" value="2 Recommended"/>
X Coordinate:	<input type="text" value="-122.157452"/>	Y Coordinate:	<input type="text" value="37.444451"/>	Z Coordinate:	<input type="text" value="13"/>
Implementation:	Priority <input type="text" value="4"/>	Phase	<input type="text" value="Phase 2"/>	Date	<input type="text" value="2041-2060"/>
				Status	<input type="text" value="Open"/>
Notes:	<input type="text" value="IMAGE:IMG_0800"/>

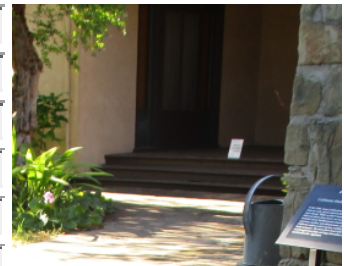
Field Date:	<input type="text" value="12/2/2016"/>	Report Date:	<input type="text" value="1/6/2017"/>	Barrier #:	<input type="text" value="7B"/>
Facility:	<input type="text" value="Williams House - Museum of American Heritage"/>				
Location:	<input type="text" value="Walkway - Performance Area"/>				
Official Responsible:	<input type="text" value="City of Palo Alto"/>				
Facility Function:	<input type="text" value="Public"/>	Dwg:	<input type="text" value="1 of 3"/>		
Barrier Area:	<input type="text" value="Stairways"/>	Remediation:	<input type="text" value="Required"/>		
Barrier Type:	<input type="text" value="Contrasting Color - Exterior"/>				
Barrier Description:	<input type="text" value="No contrasting color on each tread of exterior stairway"/>				
Code References:	<input type="text" value="CBC 11B-504.4.4.1"/>				
As Built Description:	<input type="text" value="Treads lack contrasting color defined as 70% contrast"/>

Proposed Solution:	<input type="text" value="Provide contrasting color on each tread"/>				
As-Built Meas:	<input type="text" value="4"/>	Quantity:	<input type="text" value="LF or T"/>	Cost Estimate:	<input type="text" value="\$140.00"/>
				BSR:	<input type="text" value="2 Recommended"/>
X Coordinate:	<input type="text" value="-122.157452"/>	Y Coordinate:	<input type="text" value="37.444451"/>	Z Coordinate:	<input type="text" value="13"/>
Implementation:	Priority <input type="text" value="4"/>	Phase	<input type="text" value="Phase 2"/>	Date	<input type="text" value="2041-2060"/>
				Status	<input type="text" value="Open"/>
Notes:	<input type="text" value="IMAGE:IMG_0800"/>

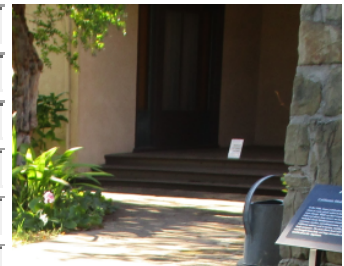
Field Date:	12/2/2016	Report Date:	1/6/2017	Barrier #:	7D
Facility:	Williams House - Museum of American Heritage				
Location:	Walkway - Performance Area				
Official Responsible:	City of Palo Alto				
Facility Function:	Public	Dwg:	1 of 3		
Barrier Area:	Stairways	Remediation:	Recommended		
Barrier Type:	Handrail - Intermediate >88" wide				
Barrier Description:	Stairway more than 88" in width lacks at least 1 intermediate handrail for each 88" of width				
Code References:	Performance Standard				
As Built Description:	No handrails provided at stairway wider than 88"				
Proposed Solution:	Provide one intermediate handrail per 88" stairway clear width				
As-Built Meas:	8	Quantity:	LF	Cost Estimate:	\$1,800.00
				BSR:	2 Recommended
X Coordinate:	-122.157452	Y Coordinate:	37.444451	Z Coordinate:	13
Implementation:	Priority 4	Phase	Phase 2	Date	2041-2060
				Status	Open
Notes:	IMAGE:IMG_0800
