# CASE STUDY

## Commercial Deconstruction

*A Deconstruction Pilot Project of the International Telephone and Telegraph (ITT) Building in the City of Palo Alto*

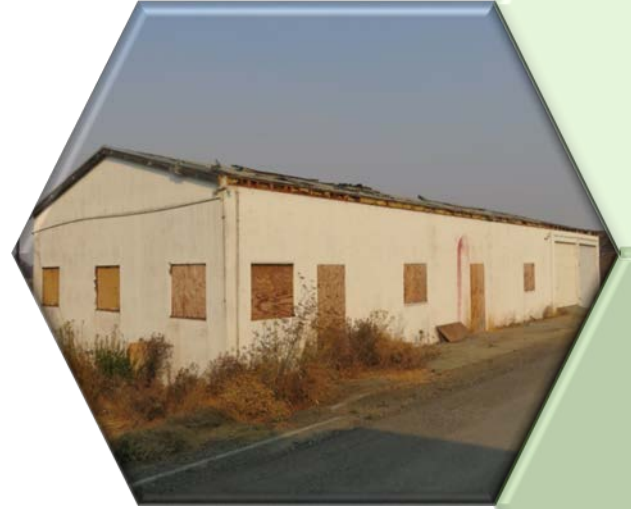
ITT office building before deconstruction.

The 2,580 square foot building, known as the International Telephone and Telegraph (ITT) office building (Image 1), was built in the 1950's and is located within the Emily Renzel Wetlands, East of Highway 101 in Palo Alto. ITT, which consisted of a wood framed structure with a concrete foundation, first underwent an abatement of lead containing materials and then was systematically disassembled, the materials source separated and select parts salvaged for donation to a reuse organization.

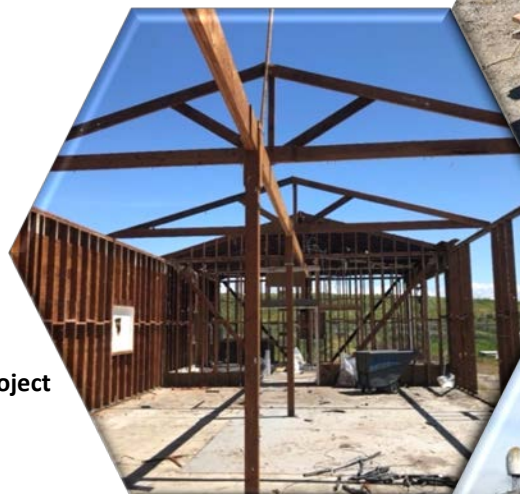
- A portion of lumber salvaged
- Deconstruction day 7 of the project
- Debris boxes set up

The team first identified the materials that could be salvaged for reuse. A representative from TRP, a reuse organization in Oakland, came to the site and conducted a salvage survey to identify materials acceptable for reuse. The acceptable materials included structural lumber (2x4, 2x6, 2x8), two air conditioning condenser units, interior doors (solid, slabs with jams and hardware), fluorescent light fixtures, kitchenette cabinets, and whiteboards. This list of materials to be salvaged for reuse was included in the deconstruction project scope of work (SOW).
