# Historic Resources Board

**Summary Title:** 567 Hale (Tobey House)

**Title:** PUBLIC HEARING: 567 Hale Street [21BLD-02531]: Request for Historic Resources Board Review of a Building Permit Application for Consistency with the Secretary of the Interior's Standards. The Project Includes Exterior Modifications to a Local Historic Resource Category II. Zone District: R-1 (10,000). Environmental Assessment: Exempt from the California Environmental Quality Act per Sections 15268 (Ministerial Projects). For More Information Contact the Project Planner Danielle Condit at [danielle.condit@cityofpaloalto.org](mailto:danielle.condit@cityofpaloalto.org).

A Remodel For The:  
**SUN~PAO FAMILY**  
567 HALE STREET  
PALO ALTO, CA 94301

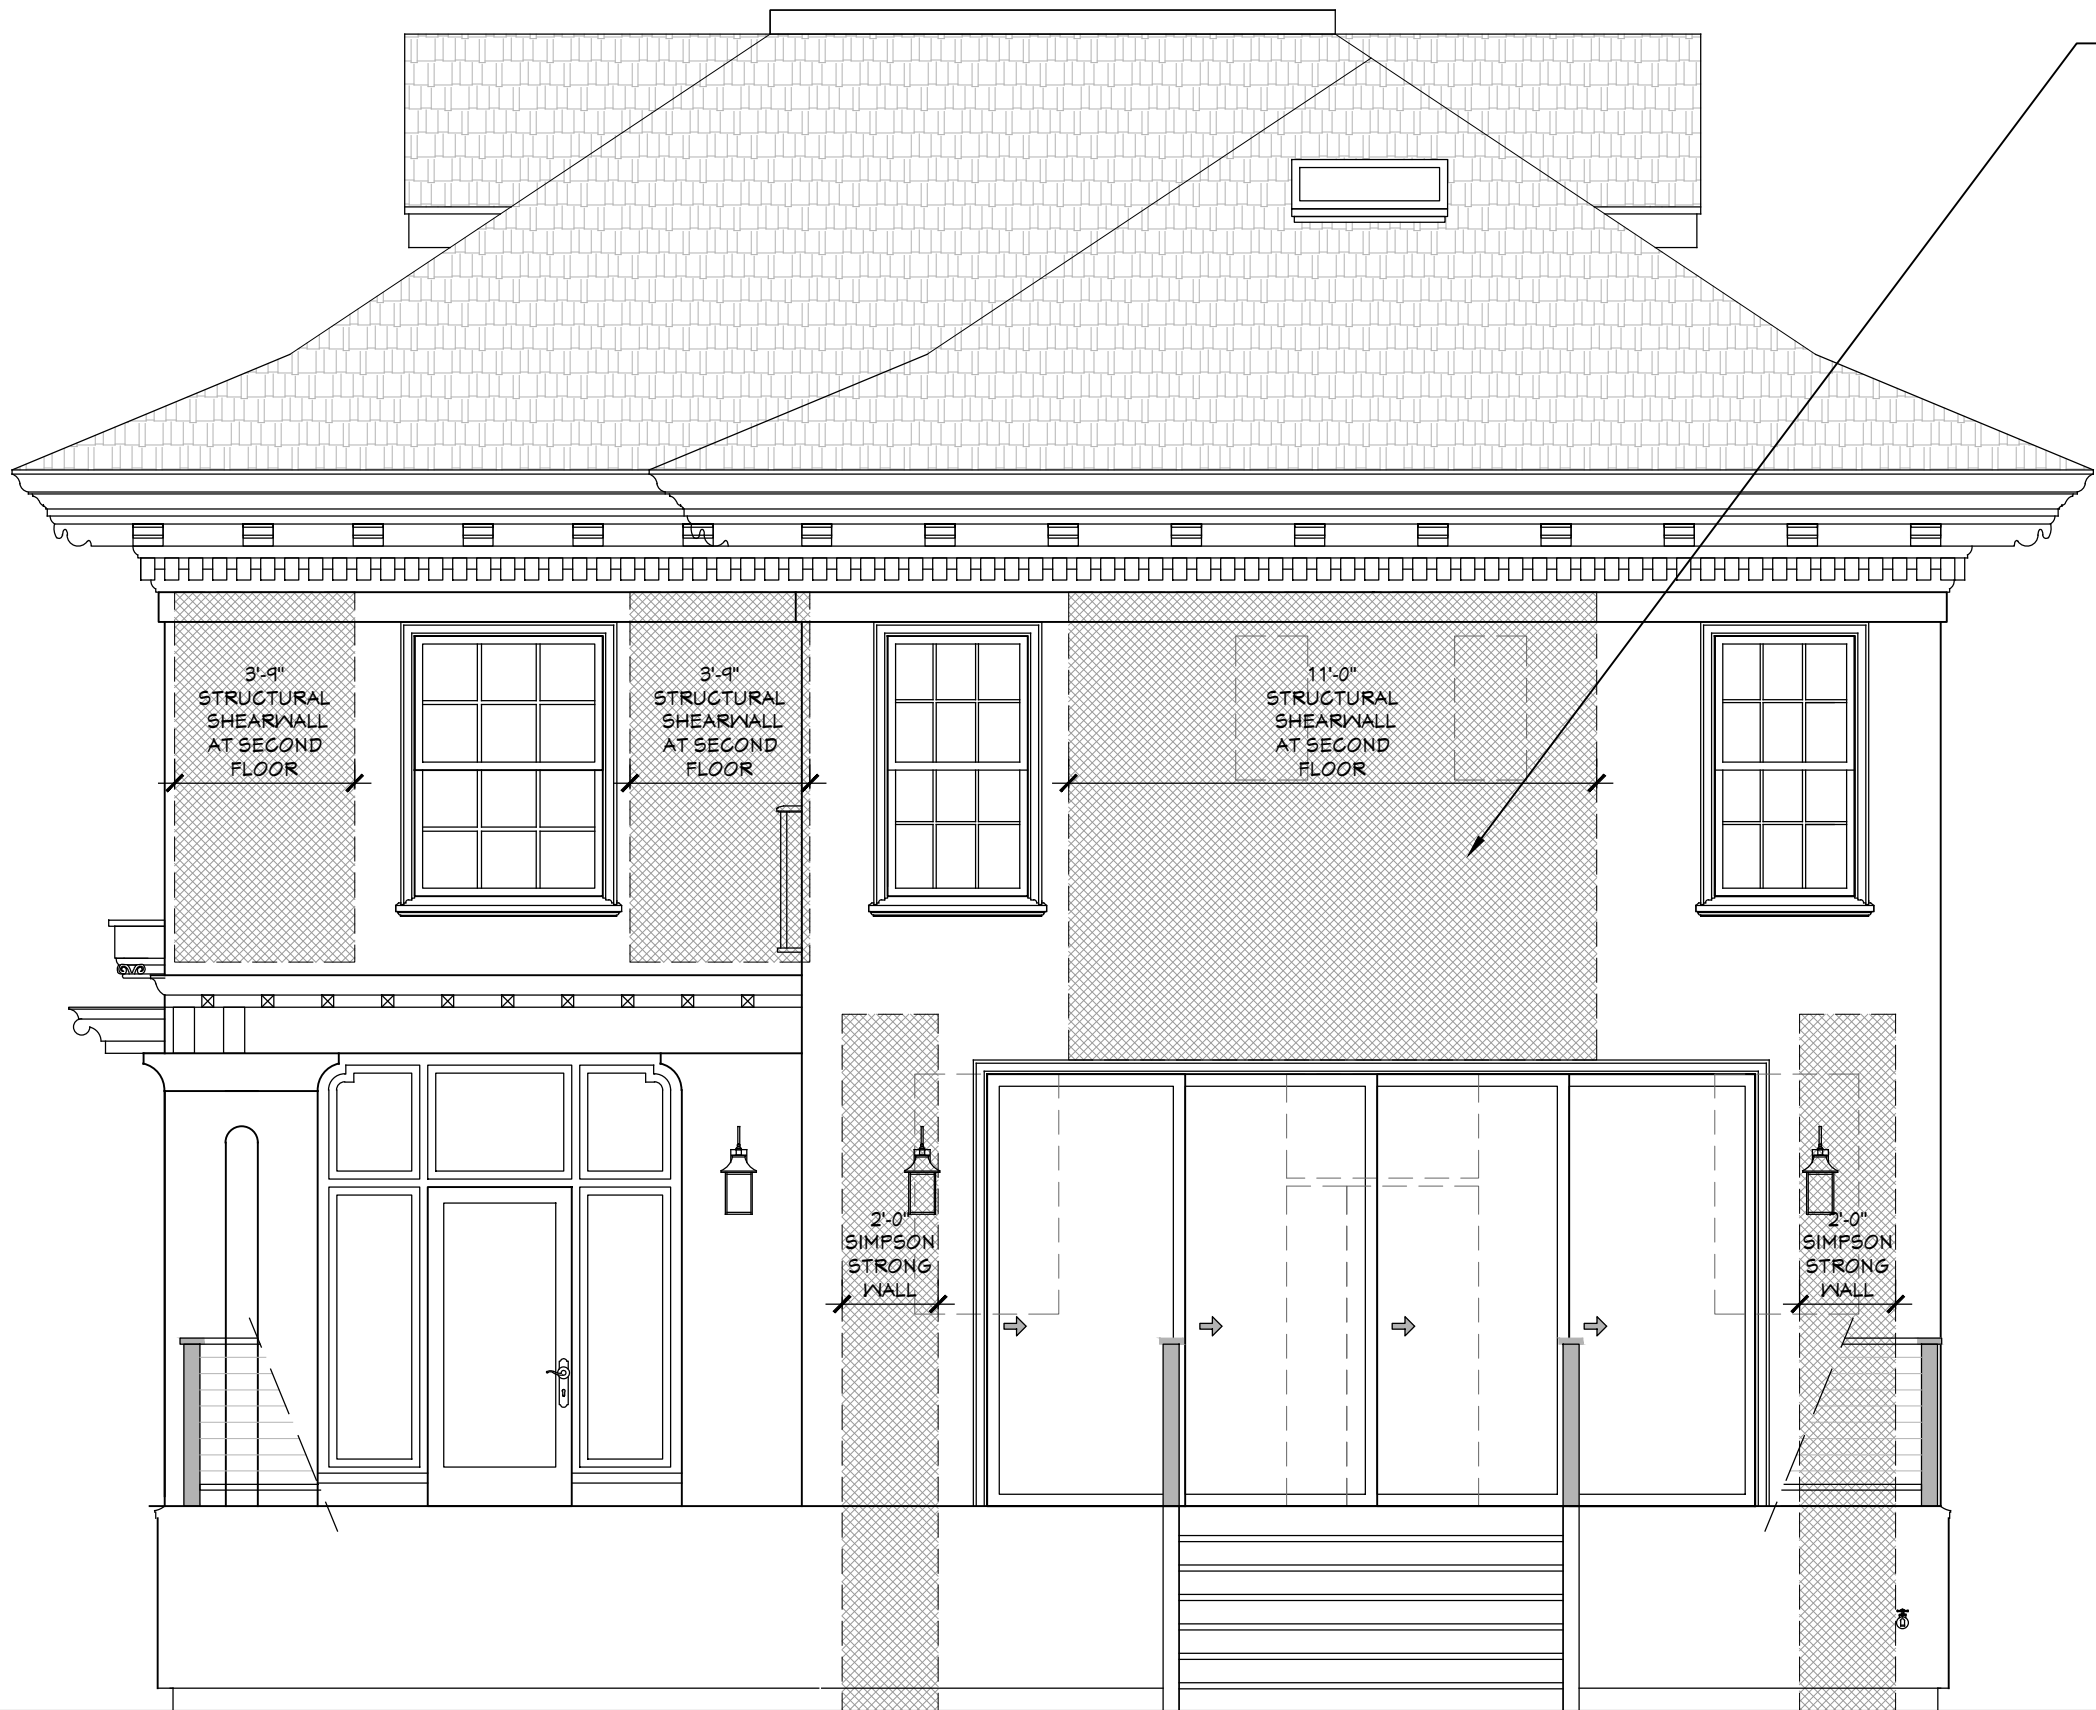
SHEAR WALL LOCATIONS REAR ELEVATION  
scale: 1/4"-1'-0"

REMOVE EXISTING STUCCO SIDING AND INSTALL STRUCTURAL SHEAR WALLS AS REQUIRED FOR STRUCTURAL UPGRADE  
REPLACE STUCCO TO MATCH (AS NEEDED)  
3 COATS MINIMUM,  
OVER METAL LATH OVER BUILDING PAPER  
OVER STRUCTURAL SHEATHING OVER  
EXISTING STUD FRAMING, WITH NEW R-15 INSULATION

The proposed method of installation of shear walls for structural upgrade will be to “replace stucco to match (as needed), 3 coats minimum, over metal lath, over building paper, over structural sheathing, over existing stud framing, with new R-15 insulation,” which is noted on elevation drawing sheets.

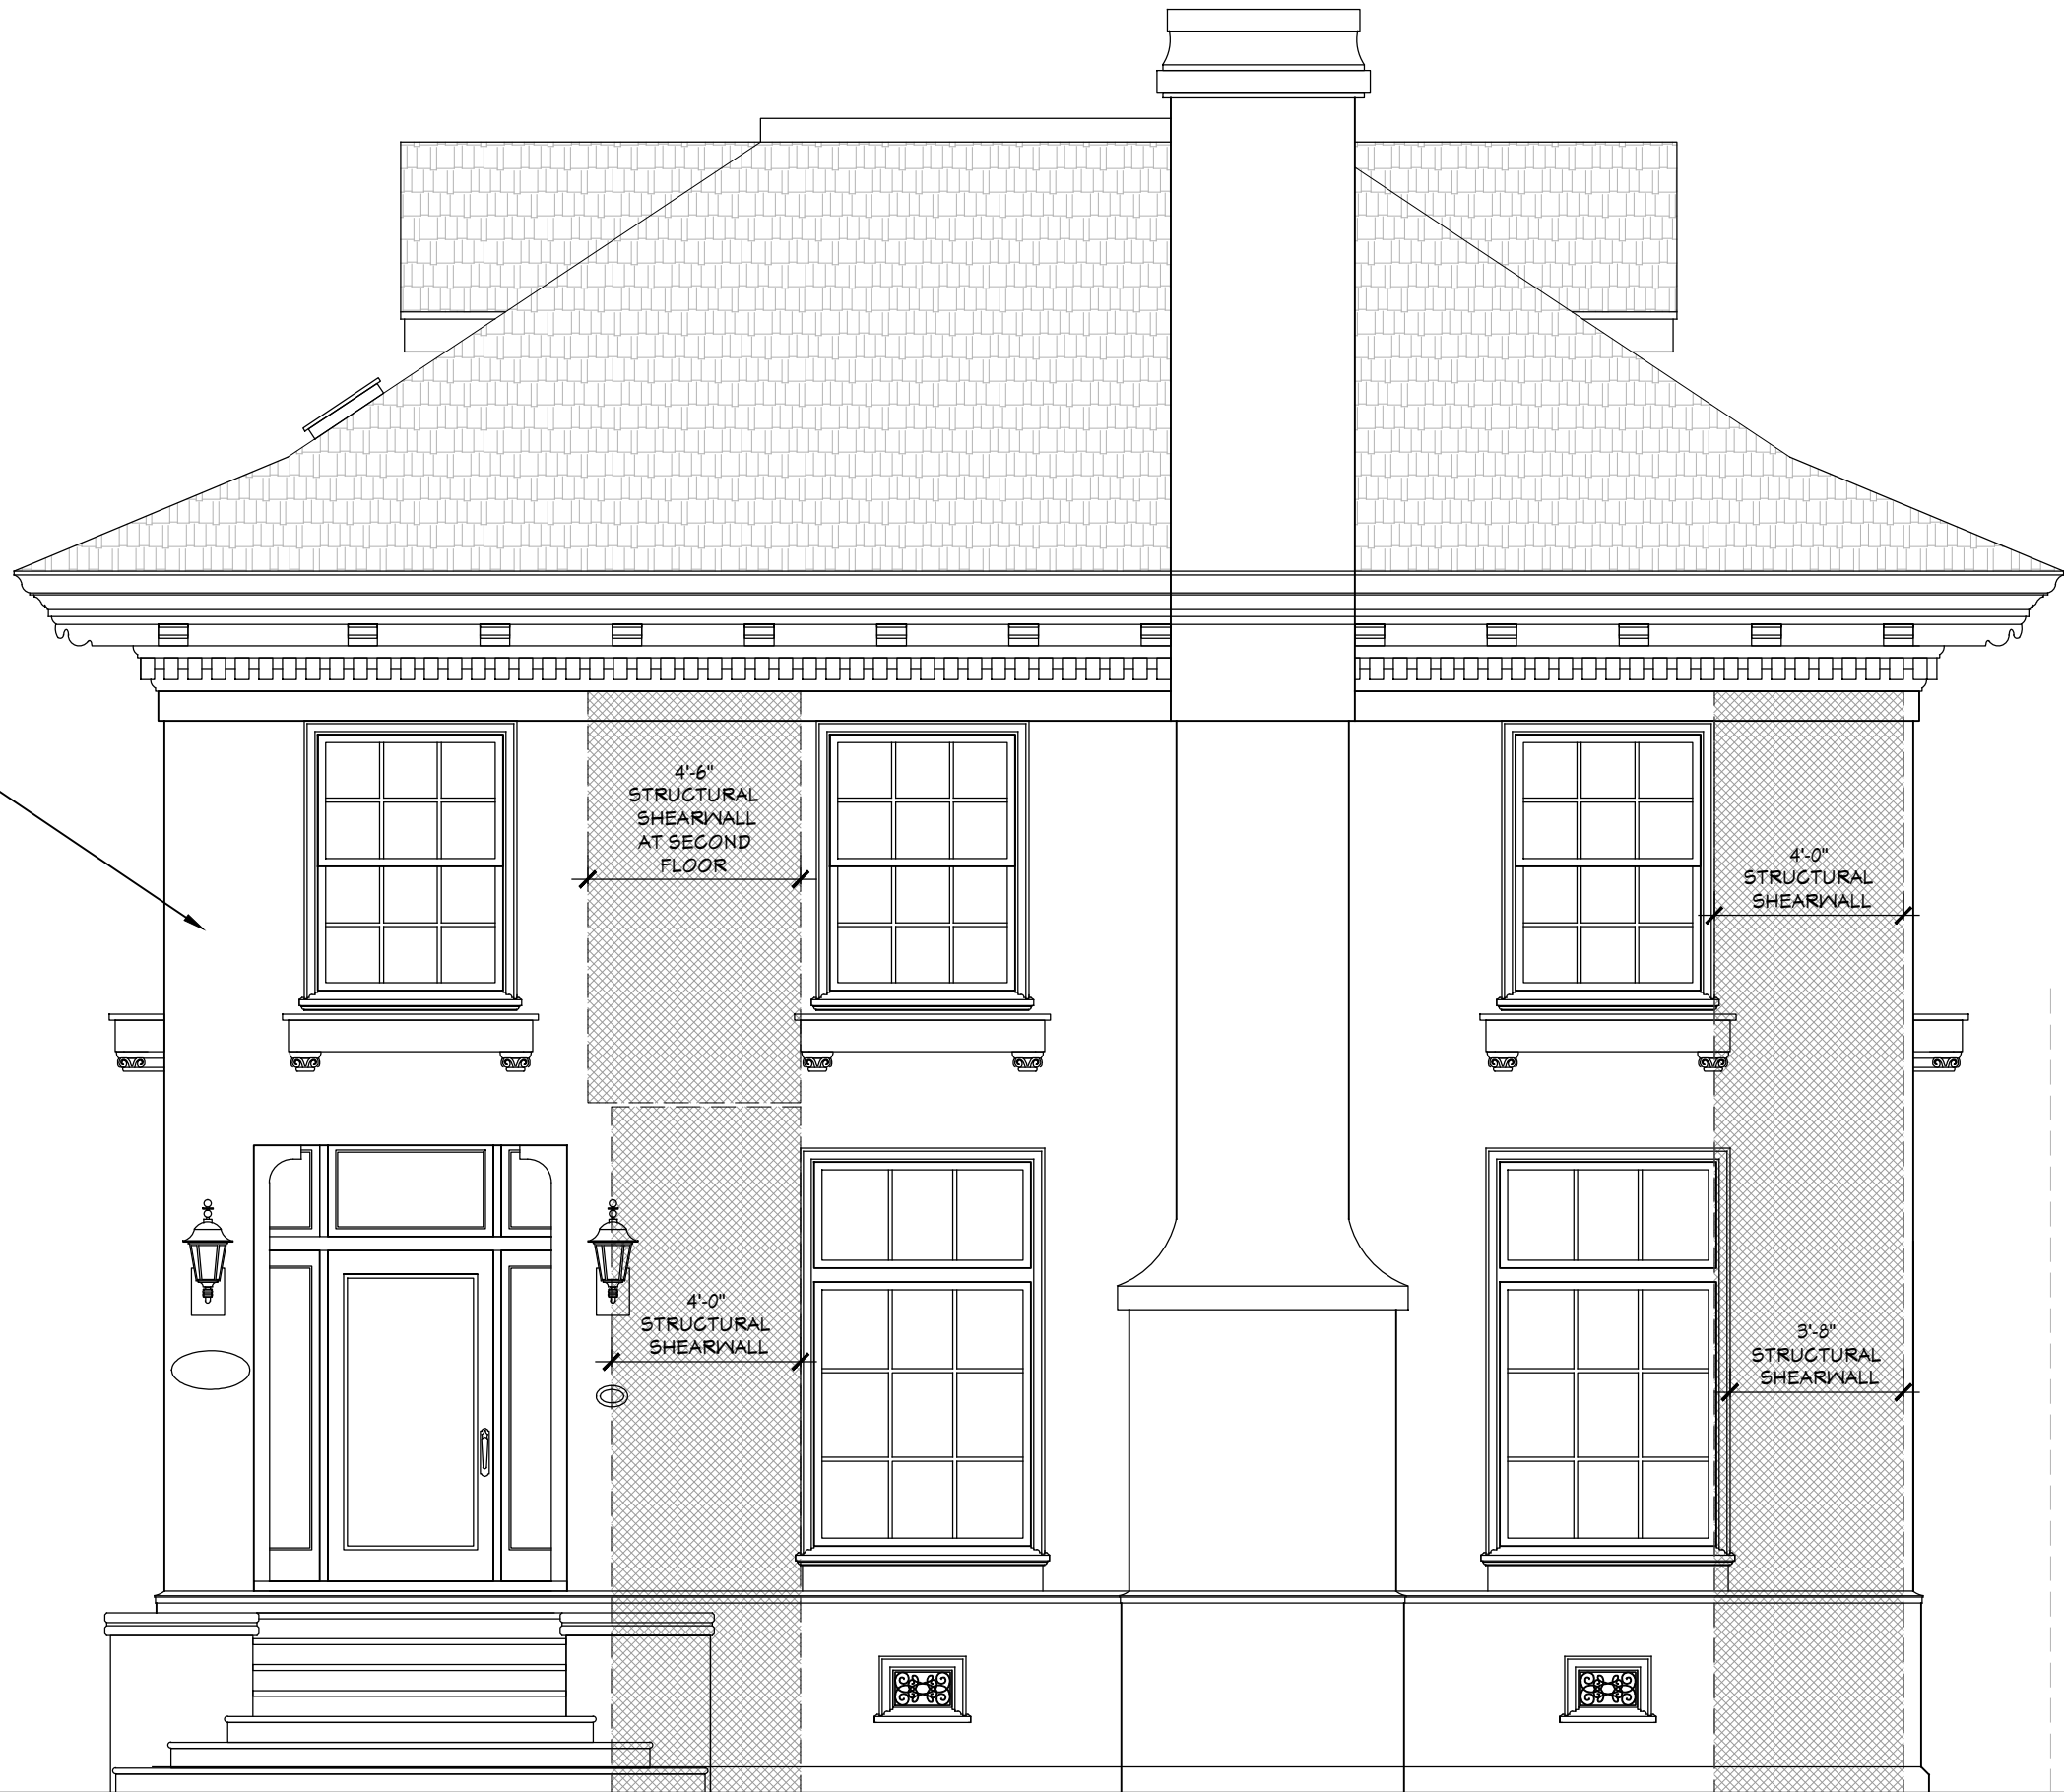
SHEAR WALL LOCATIONS FRONT ELEVATION  
scale: 1/4"-1'-0"

REMOVE EXISTING STUCCO SIDING AND INSTALL STRUCTURAL SHEAR WALLS AS REQUIRED FOR STRUCTURAL UPGRADE  
REPLACE STUCCO TO MATCH (AS NEEDED)  
3 COATS MINIMUM,  
OVER METAL LATH OVER BUILDING PAPER  
OVER STRUCTURAL SHEATHING OVER  
EXISTING STUD FRAMING, WITH NEW R-15 INSULATION

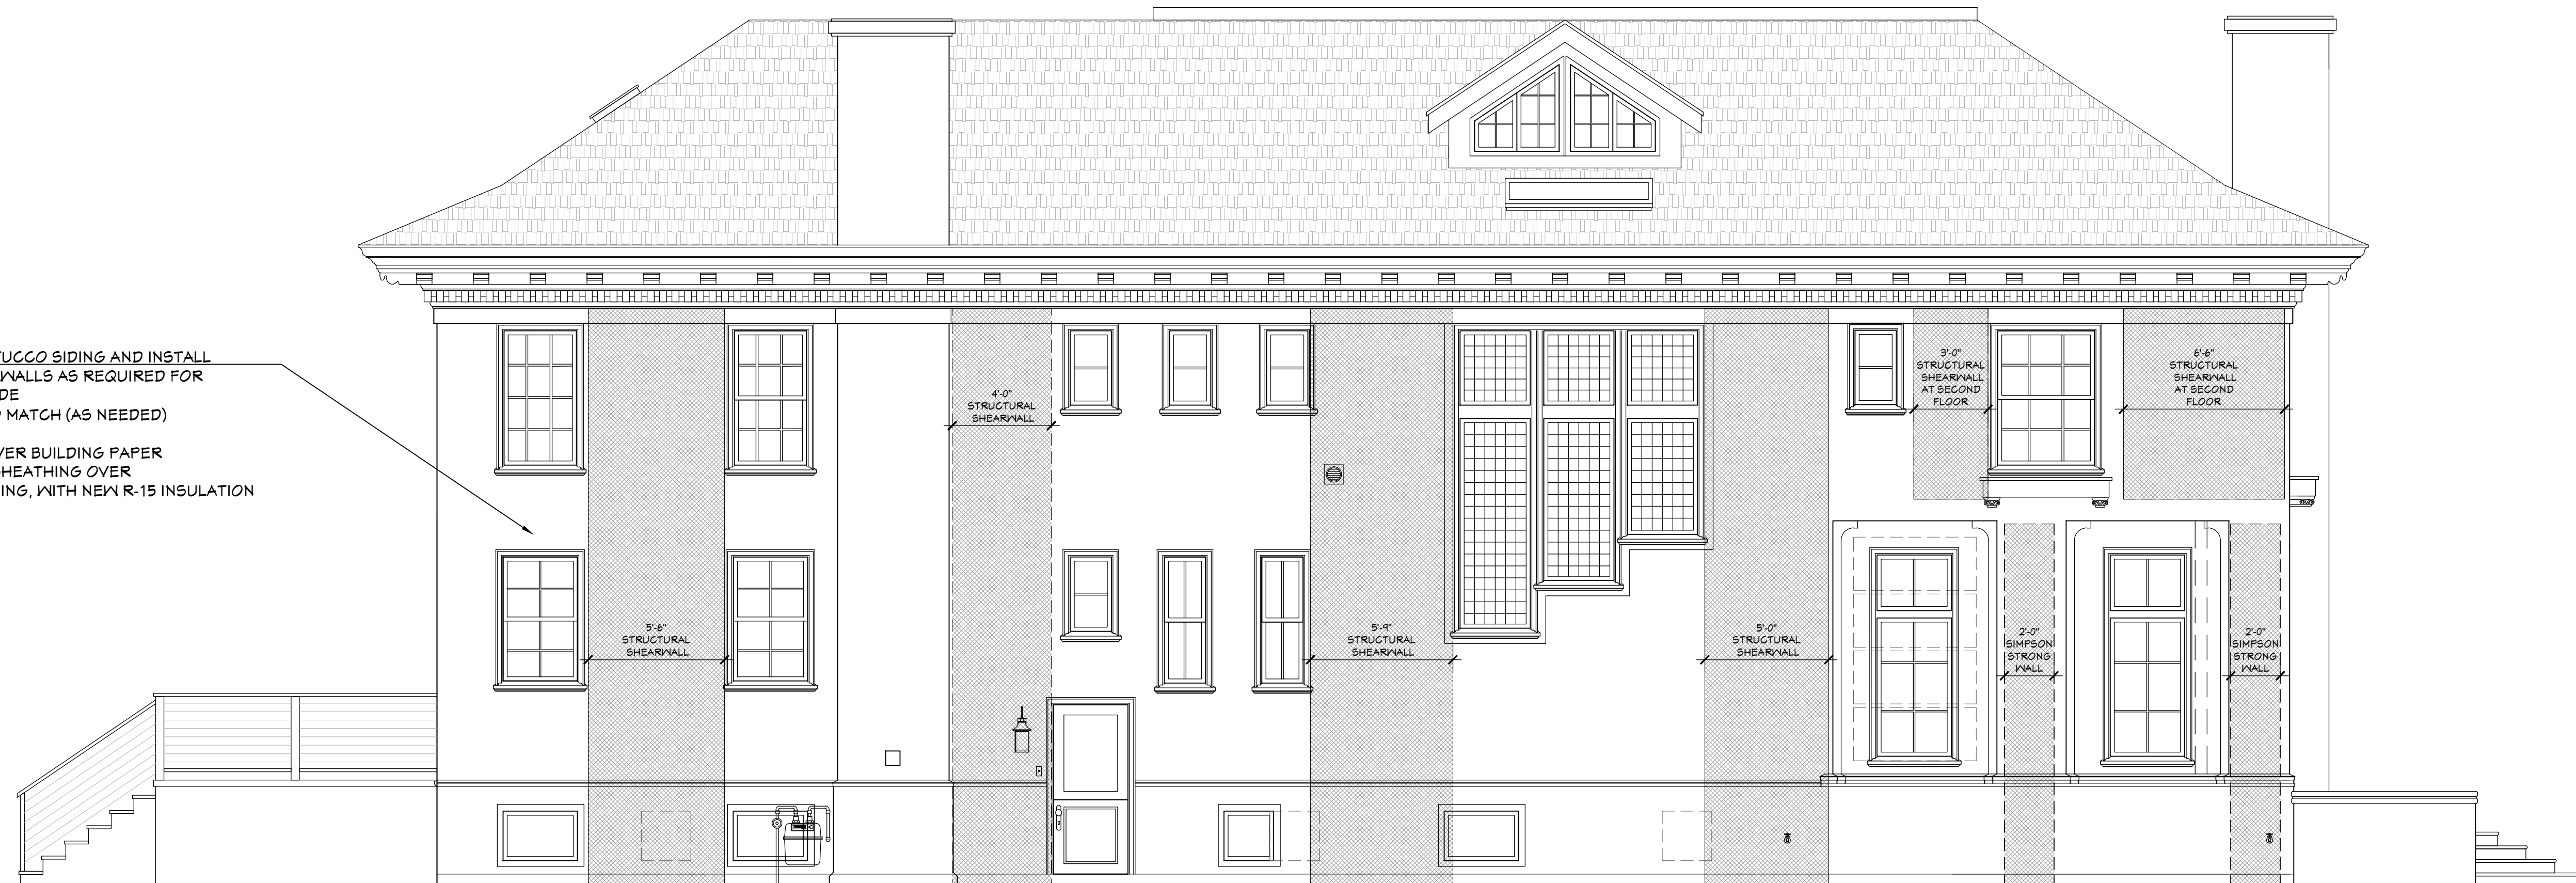
**SHEARWALL LOCATIONS DRIVEA SIDE (NORTHWEST) ELEVATION**  
scale: 1/4"-1'-0"

REMOVE EXISTING STUCCO SIDING AND INSTALL  
STRUCTURAL SHEAR WALLS AS REQUIRED FOR  
STRUCTURAL UPGRADE  
REPLACE STUCCO TO MATCH (AS NEEDED)  
3 COATS MINIMUM,  
OVER METAL LATH OVER BUILDING PAPER  
OVER STRUCTURAL SHEATHING OVER  
EXISTING STUD FRAMING, WITH NEW R-15 INSULATION

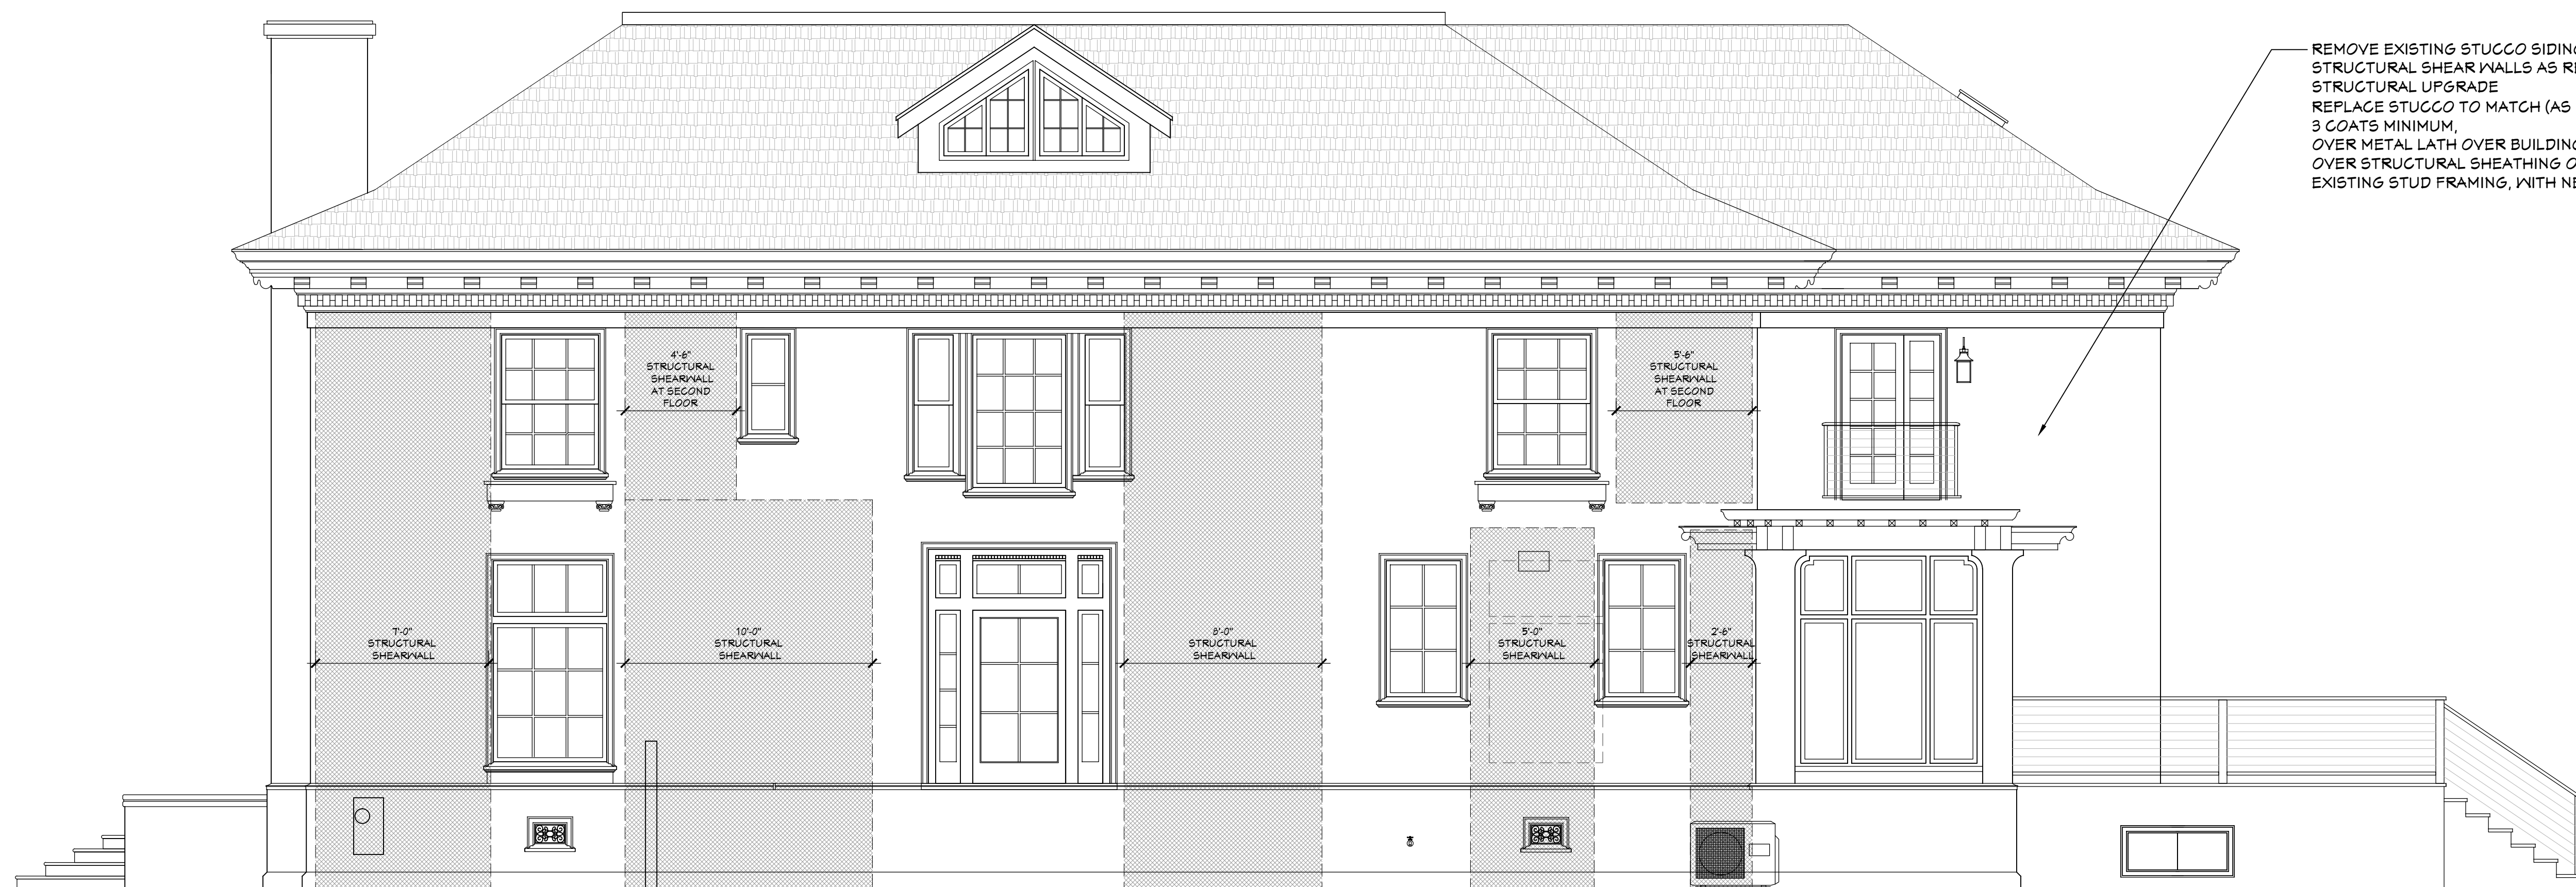
**SHEARWALL LOCATIONS INTERIOR SIDE (SOUTH EAST) ELEVATION**  
scale: 1/4"-1'-0"

REMOVE EXISTING STUCCO SIDING AND INSTALL  
STRUCTURAL SHEAR WALLS AS REQUIRED FOR  
STRUCTURAL UPGRADE  
REPLACE STUCCO TO MATCH (AS NEEDED)  
3 COATS MINIMUM,  
OVER METAL LATH OVER BUILDING PAPER  
OVER STRUCTURAL SHEATHING OVER  
EXISTING STUD FRAMING, WITH NEW R-15 INSULATION

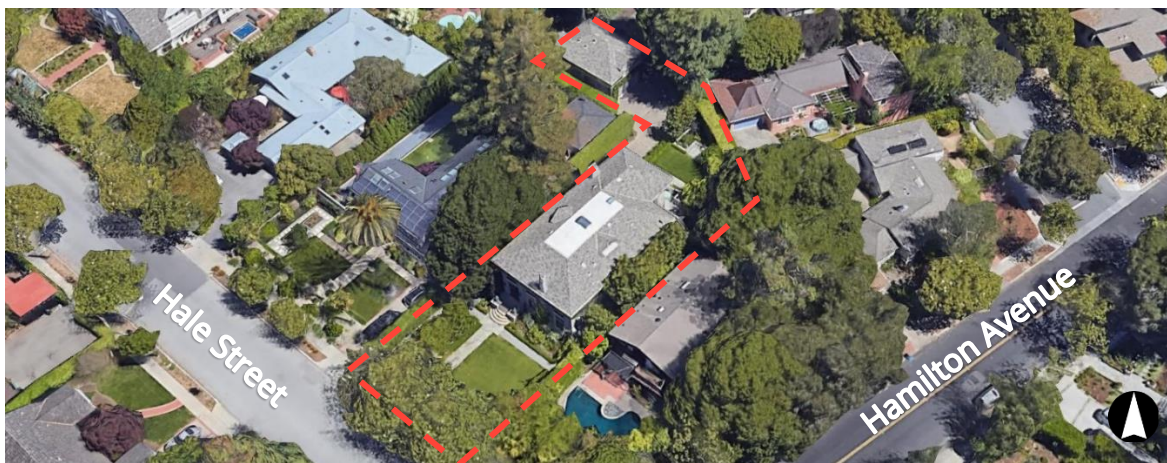
Figure 1: Aerial photograph of 567 Hale Street, with the approximate parcel boundary shown in dashed red line. Source: Google Maps, 2021. Edited by Page & Turnbull.

The L-shaped property at 567 Hale Street contains a two-story residence and a freestanding, two-story garage, both designed in the Classical Revival style (**Figure 1**). A paved driveway connects the garage to Hale Street.

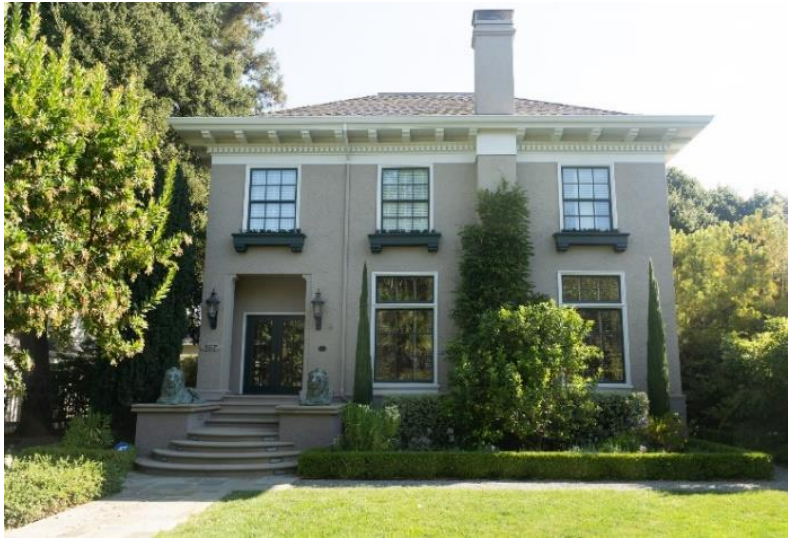
Figure 2: Primary (southwest) façade of 567 Hale Street. Looking northeast.

The primary façade of 567 Hale Street is asymmetrically designed with an entry portico at the left (west) corner of the first story and a chimney shaft to the right (south) of the center. On the first floor, two full height fixed wood, nine-pane windows flank the chimney shaft (**Figure 2**). These windows are set in molded frames with molded sills and include three-pane, divided-lite transoms above. Below each of these windows is a wooden vent with typically molded wood frames. The second story features three typical double-hung six-over-six windows set in decorative molded frames with molded sills. Below each of these windows is a wood window box planter with decorative corbels.

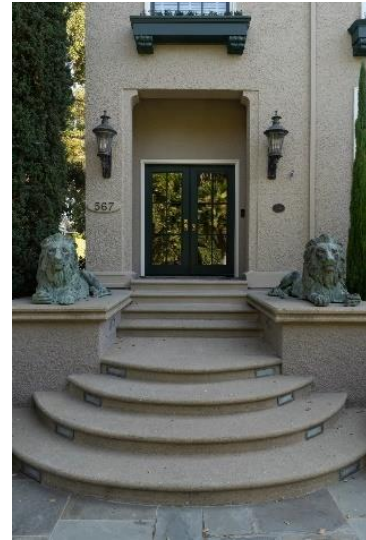
Figure 3: Detail of entry. Looking northeast.

The primary entrance sits within the portico at the west end of the primary façade; two shaped jam-shaft pilasters with molded bases frame the opening (**Figure 3**). The entry is accessed by a straight stair with curved treads, bullnose treads, electric riser-mounted step lights, and two metal lion sculptures on stuccoed bases. Two wall-mounted lanterns flank the portico, which contains a pair of wood French doors.

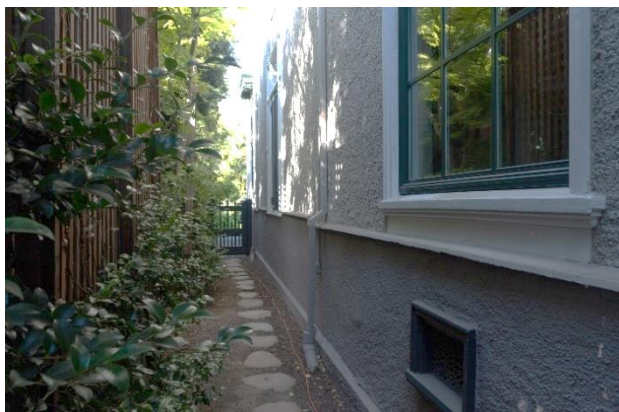
Figure 4: View down the first story of the southeast façade, showing path. Looking southwest.

The southeast façade faces a small river stone walkway along the southeast property line and is separated from the rear garden of the residence by a small metal gate (**Figure 4**). At the first story, there are three windows. At the south (left) and east (right) sides are two fixed wood nine-pane windows with three-pane transoms above. Below each of these windows is a typical wood vent, like those described on the primary façade. At the center of the façade, there is a large window arrangement set in a typical wood sash with wood sills and mullions. This arrangement features a pair of multi-lite wood casement windows with pair of hinged screens and a two-lite transom above. Two divided-lite, three-pane sidelights flank this central window with a single pane transom above each sidelight. The window frame includes dentil detailing at the head (**Figure 5**).

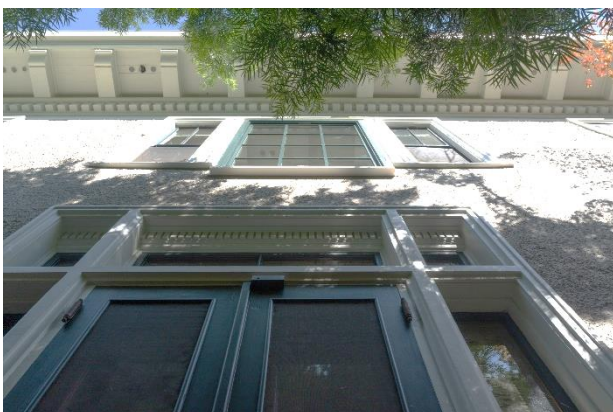
Figure 5: Windows at the center of southeast façade. Looking northwest.

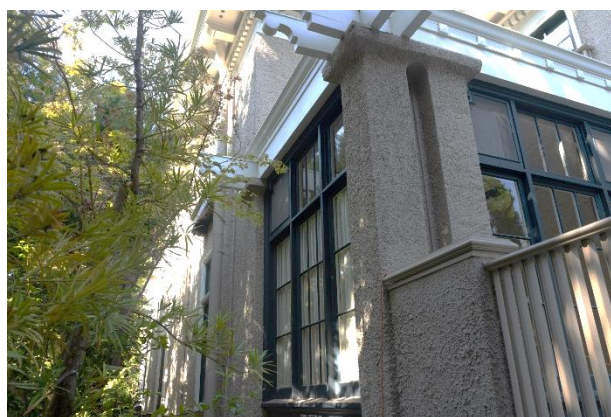
Figure 6: Enclosed porch at the east corner of the house. Looking southwest.

The southeast façade features a one-story enclosed porch at the east corner (**Figure 6 & Figure 7**). A flat roof covers this porch with pergola-style exposed joists that have been decoratively cut at the ends. The roof includes an ogee gutter at the perimeter with decorative nailhead banding below, and is supported by a shaped cluster column at the freestanding corner and two engaged columns against the house at the southeast façade and at the southeast of the northeast façade.

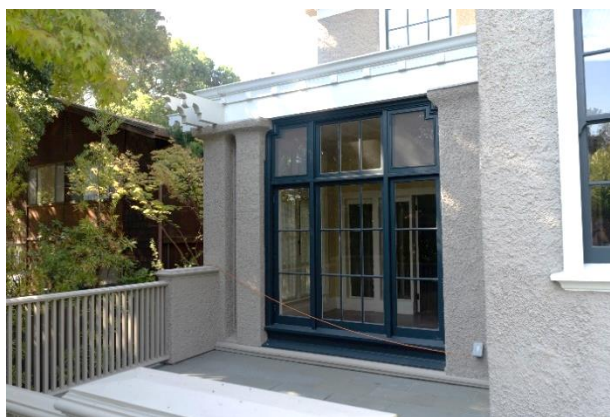
Figure 7: Enclosed porch at the east corner of the house. Looking south.

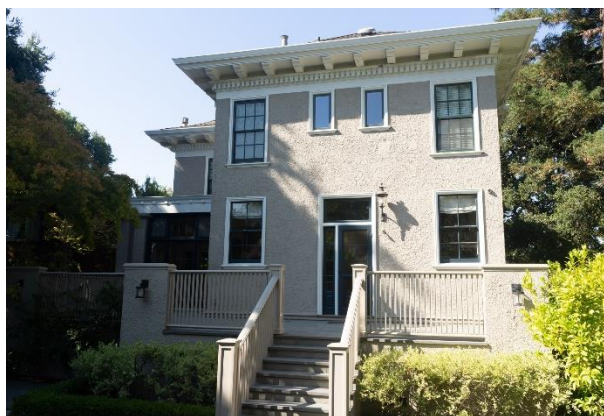
Figure 8: View of northeast façade. Looking south.

The northeast façade, to the right (north) of the enclosed porch, is symmetrically designed (**Figure 8**). At the center of the first story, there is an eight-lite glazed wood door and screen door. This door features an eight-pane sidelight to the left (east) of the door and a single-pane transom above. This rear entryway opens onto a deck and is illuminated by a single wall-mounted lantern to the upper right (north) (**Figure 9**). At the first story, there are two typical four-over-four wood windows. At the center of the second story, there is a pair of operable single-pane casement windows. There are also two typical six-over-six double-hung wood windows at the left (east) and right (north) sides of the façade (**Figure 10**).

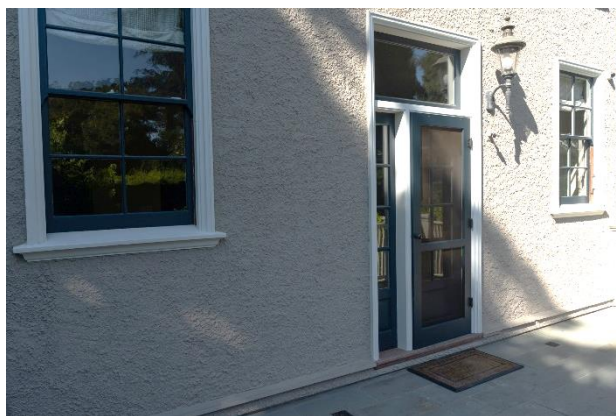
Figure 9: View of the secondary entrance at northeast façade. Looking east.

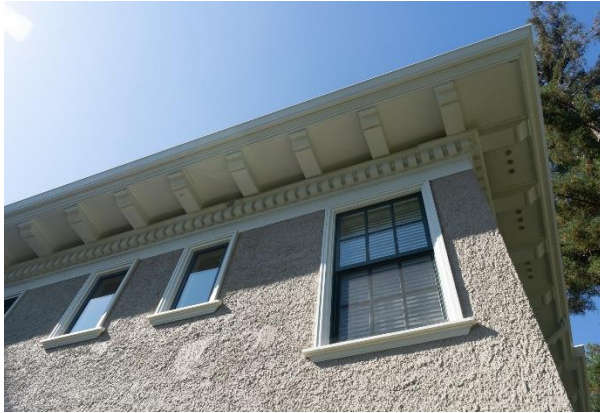
Figure 10: Second story of north corner or northeast façade. Looking south.

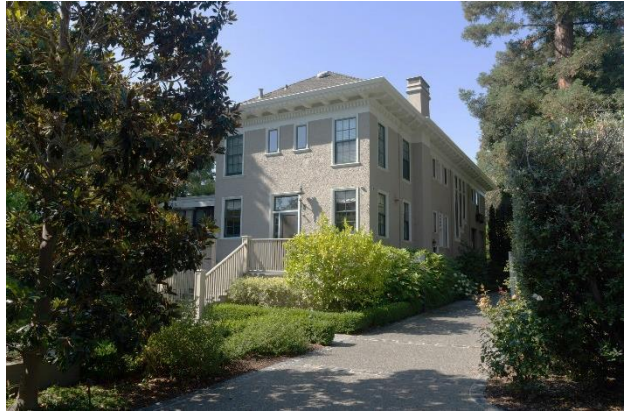
Figure 11: Oblique view of northeast façade showing northwest façade and driveway. Looking south.

The rear deck spans the entire width of the rear (northeast) façade of the house. The deck features a molded handrail and densely spaced posts between stuccoed pony walls at the corners. On-axis with the rear entrance to the house, there is a small stair into the back yard and driveway (**Figure 11**).

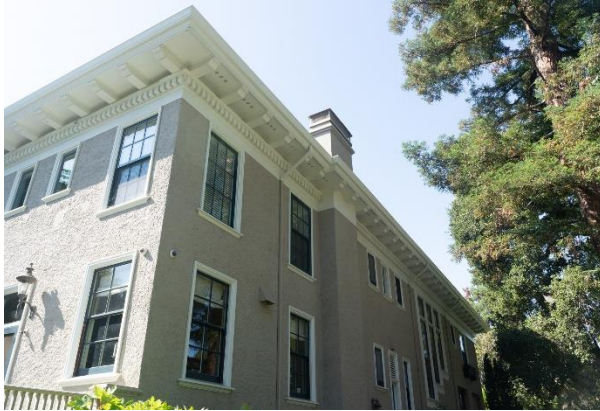
Figure 12: View of northwest façade, showing the windows at the north corner. Looking south.

The northwest façade of 567 Hale Street has a variety of fenestration. A chimney is located approximately one-quarter from the left (north) side of the façade. To the left (north) of the chimney, on the first story, there are two typical four-over-four double-hung wood windows (**Figure 12**). To the right (west) of the chimney is a partially glazed typical wood entry door onto the driveway. Above this door is a two-pane fixed wood window. To the right (west) area fixed two-pane window with a ventilation grille above and a two-over-two double-hung wood window (**Figure 13**). Further to the right (west) is a group of three large stair windows with transoms above. These windows are set in typical frames and feature wood mullions and leaded amber glass panes in a grid arrangement (**Figure 14**). On the right (west) side of the façade, there are two recesses framed by shaped jam-shaft pilasters with molded bases that used to be openings on the side of the primary entrance portico but have since been infilled. The left (north) recess contains a full-height leaded glass window, and the right (west) recess is blind (**Figure 15**). Below the first story are seven typical wood vents, three to the left (north) of the chimney, two to the right (west) of the side entry door, and two below the large stair window.

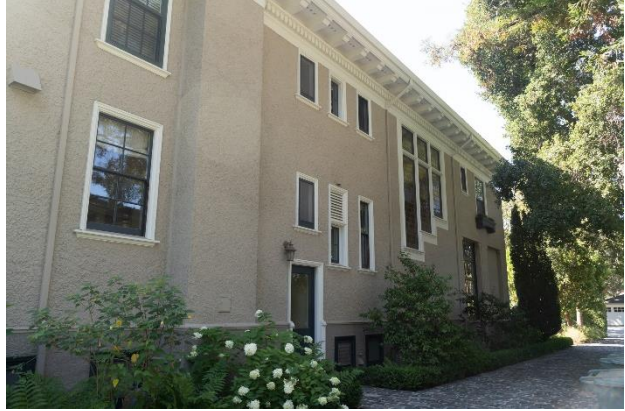
Figure 13: View of northwest façade, showing the windows at the center of the facade. Looking south.

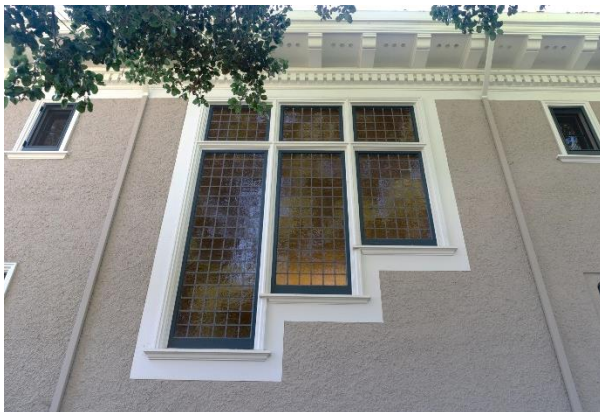
Figure 14: Detail of amber windows at the center of the façade. Looking southeast.

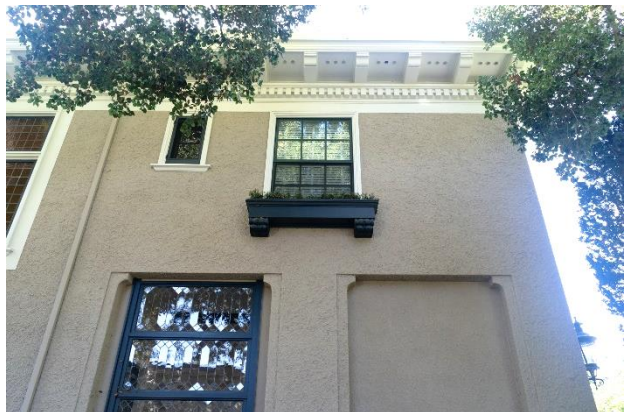
Figure 15: View of windows at the west corner of the house. Looking southeast.

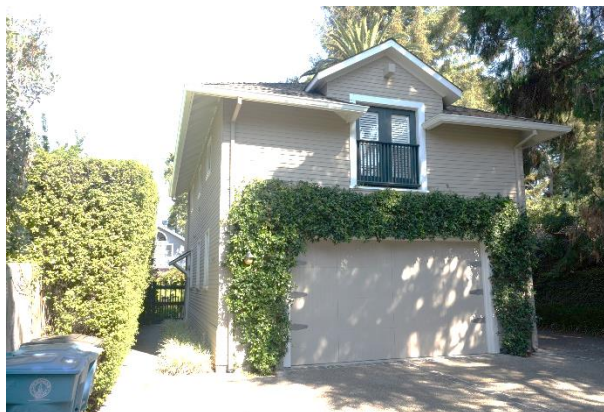
Figure 16: View of southeast façade of garage, with garage door and dormer. Looking northwest.

The primary façade of the garage is distinguished by a wood bifold door with exposed hardware at the first story, and a French door with a small wood handrail centered on a dormer at the second story. This gable-roof dormer features an exposed ridge beam at its center and anchors the returning eaves of the primary garage roof (**Figure 16**).

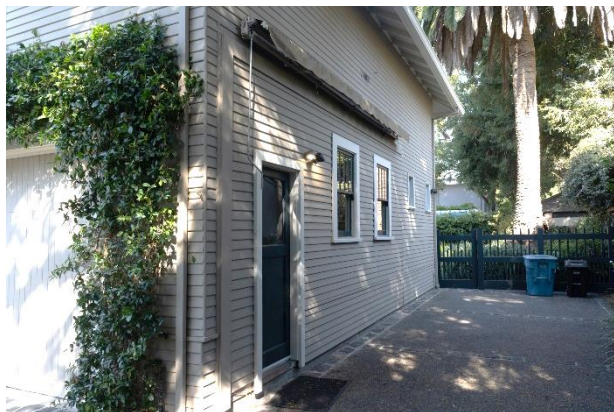
Figure 17: Oblique view of northeast façade of garage. Looking west.

The northeast façade has a large portion at the left (east) side of the first story façade where the siding has been replaced in-kind but does not line up with the older siding. The superior and left (east) sutures of this portion of siding have been covered with a wood plank (**Figure 17**). Above this area, a retractable awning is mounted to the wall. From the left (east) to the right (north), there is a partially glazed wood door and two four-over-one double-hung wood windows set in wood sashes and sills. There are two small single-pane typical fixed frame windows and a security light to the right (north) of this fenestration. At the north corner of the building, a metal gate controls access to the northwest area of the lot.

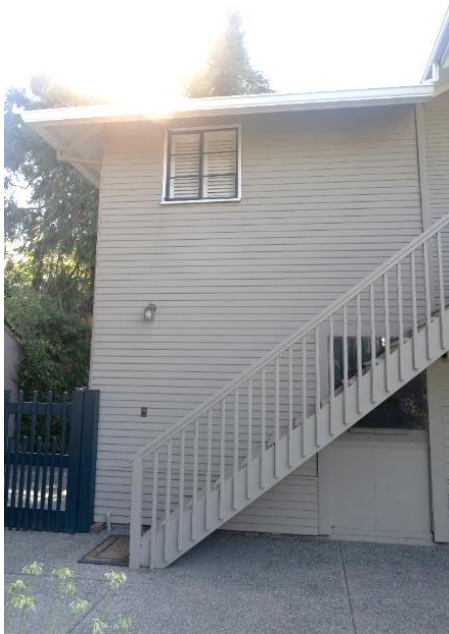
Figure 18: View of northwest façade of garage .  
 Looking southeast.

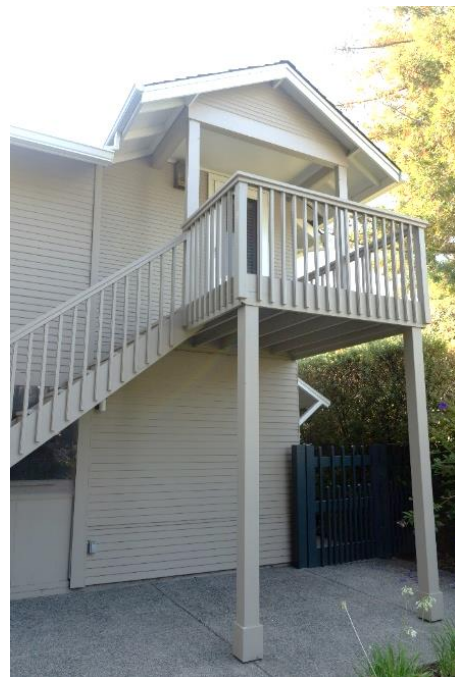
Figure 19: Oblique view of northwest façade of garage, stair and gabled entry at second story.  
 Looking south.

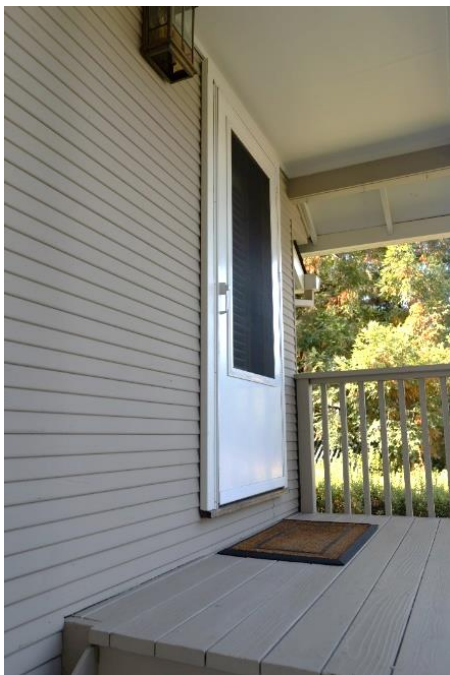
Figure 20: Oblique view of entry at second story of garage. Looking east.

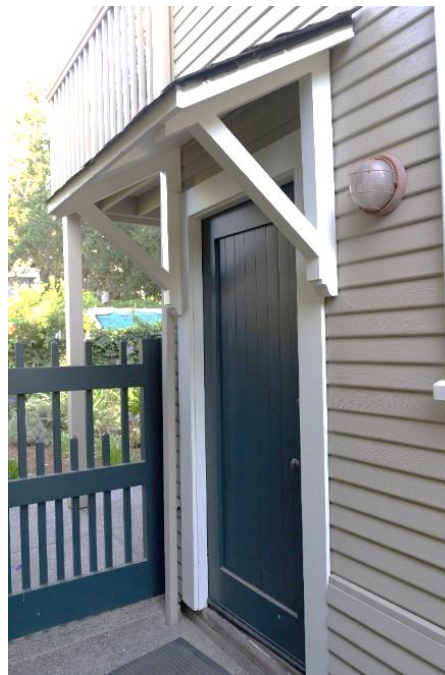
Figure 21: Oblique view of covered first floor entry at the west corner of the garage. Looking north.

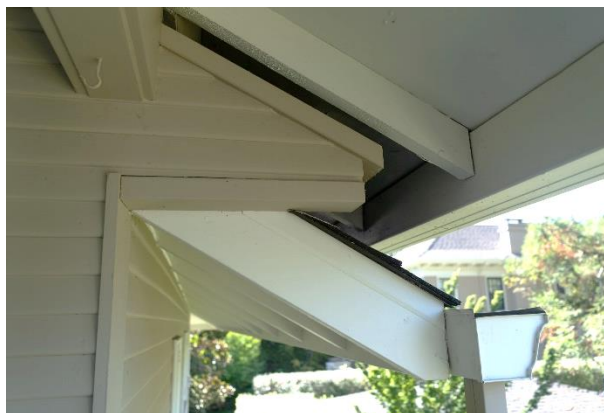
Figure 22: Detail of gabled roof over entry at the second story of the garage. Looking southeast.

north corner of the garage (). This dormer covers the entrance to the second floor. This entrance is marked by a fully glazed wood door and includes a vinyl screen (). From the bottom of the deck at the second story to the roof, beneath the gabled dormer, the double ogee wood siding is smaller than the rest of the garage siding (**Figure 22**). At the left (north) side of the second story, there is a six-pane divided-lite steel window set in a typical wood sash and frame.

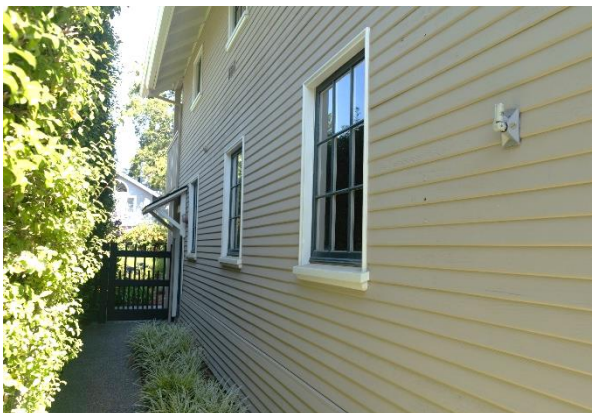
Figure 23: Secondary entrance at south end of west façade. Looking east.

At the west corner of the garage, a metal gate controls access to the northwest area of the lot. From the left (west) to the right (south), the first level of the façade has a solid wood door surrounded by an flat wood frame and protected by a shed roof with wood brackets (). Beyond the door are three equally spaced six-pane fixed wood windows. At the second story, three windows align with the first story windows (**Figure 23**). The left (west) window is a single pane wood casement window. The two windows to the right (south) of the single pane window are six-pane wood casement windows.

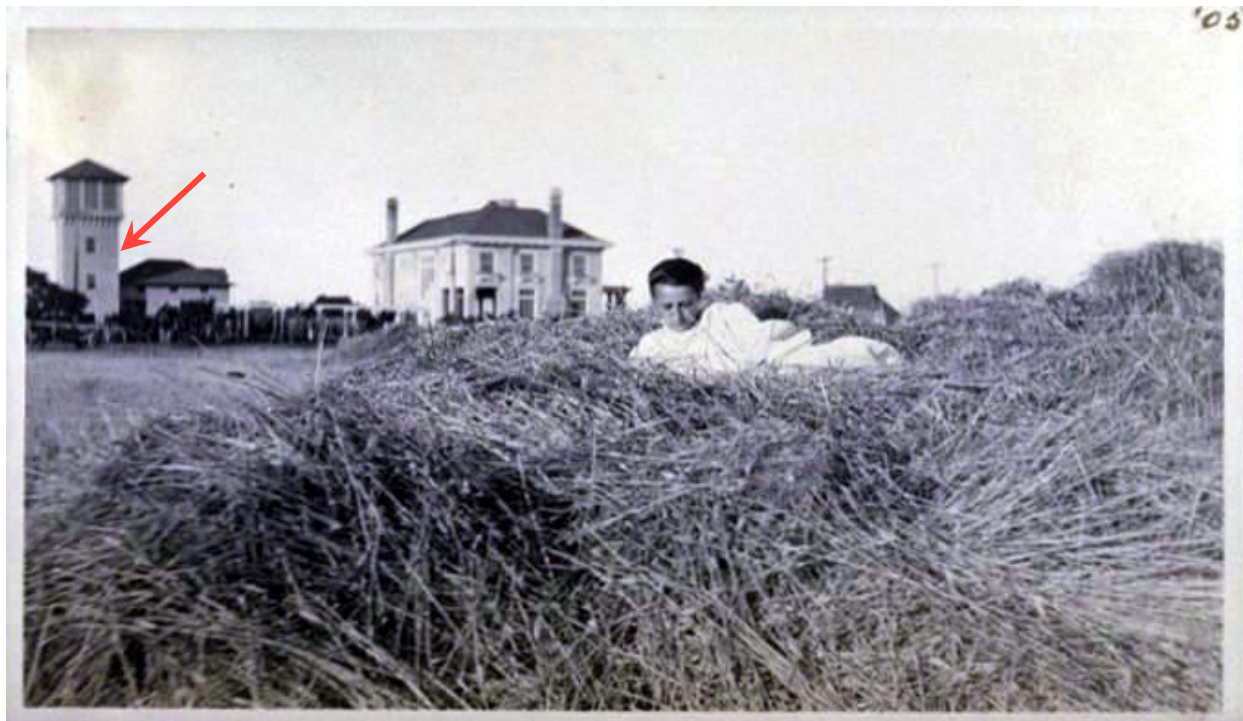
Figure 24: A 1905 photograph of a neighbor behind her home on University Avenue with the Tobey House at 567 Hale Street visible in the background. The auxiliary building which today is the garage is clearly visible. A red arrow highlights the tank house. Source: Palo Alto Historical Association. Edited by Page & Turnbull.

When completed in 1904, the Tobey estate contained the residence and a barn with a stable and four servants' quarters. A pair of photographs show the barn, a grape arbor extending from the northwest side of the house, and a tankhouse which is mentioned in the text of Palo Alto Historic Resources Survey as having "details [that] were not neglected by the architects" (**Figure 24 and Figure 25**).<sup>18</sup> The tankhouse's location is also confirmed in a 1946 Sanborn Fire Insurance Map

A site visit, in combination with a review of older photographs (**Figure 24, Figure 25, and Figure 30**), determined that many of the original windows on the first floor have been retained along the primary (southwest), northwest, and rear (northeast) façades. The amber-glass stair window also appears to be original. The multi-lite casement windows at the center of the southeast façade appear to be original. The glazed façades of the enclosed porch at the east corner of the house have been retained from the original designs. The garage also has original windows on the first floor, with the exception of the northeast façade, where a section of the exterior wall was replaced, and new windows were added.
