# Historic Resources Board

**Summary Title:** 567 Hale (Tobey House)

**Title:** PUBLIC HEARING: 567 Hale Street [21BLD-02531]: Request for Historic Resources Board Review of a Building Permit Application for Consistency with the Secretary of the Interior's Standards. The Project Includes Exterior Modifications to a Local Historic Resource Category II. Zone District: R-1 (10,000). Environmental Assessment: Exempt from the California Environmental Quality Act per Sections 15268 (Ministerial Projects). For More Information Contact the Project Planner Danielle Condit at [danielle.condit@cityofpaloalto.org](mailto:danielle.condit@cityofpaloalto.org).

A Remodel For The:  
**SUN~PAO FAMILY**  
567 HALE STREET  
PALO ALTO, CA 94301

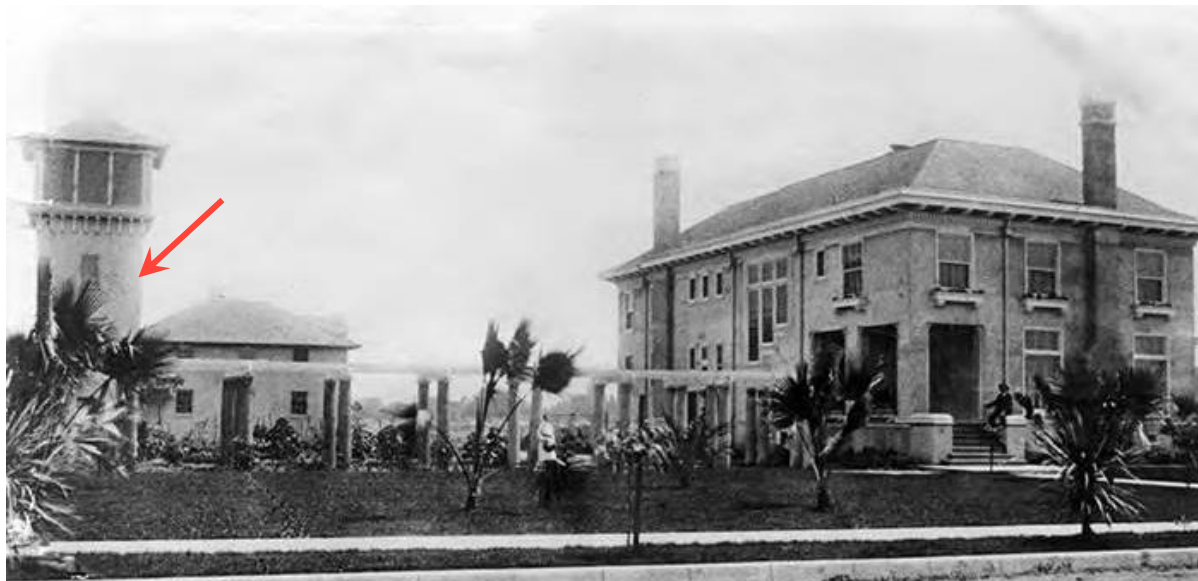
Figure 25: Undated Photograph of 567 Hale Street. The auxiliary building which today is the garage is clearly visible. A red arrow highlights the tankhouse. Source: Palo Alto Historical Association. Edited by Page & Turnbull.

When completed in 1904, the Tobey estate contained the residence and a barn with a stable and four servants' quarters. A pair of photographs show the barn, a grape arbor extending from the northwest side of the house, and a tankhouse which is mentioned in the text of Palo Alto Historic Resources Survey as having "details [that] were not neglected by the architects" (**Figure 24 and Figure 25**).<sup>18</sup> The tankhouse's location is also confirmed in a 1946 Sanborn Fire Insurance Map

A site visit, in combination with a review of older photographs (**Figure 24, Figure 25, and Figure 30**), determined that many of the original windows on the first floor have been retained along the primary (southwest), northwest, and rear (northeast) façades. The amber-glass stair window also appears to be original. The multi-lite casement windows at the center of the southeast façade appear to be original. The glazed façades of the enclosed porch at the east corner of the house have been retained from the original designs. The garage also has original windows on the first floor, with the exception of the northeast façade, where a section of the exterior wall was replaced, and new windows were added.

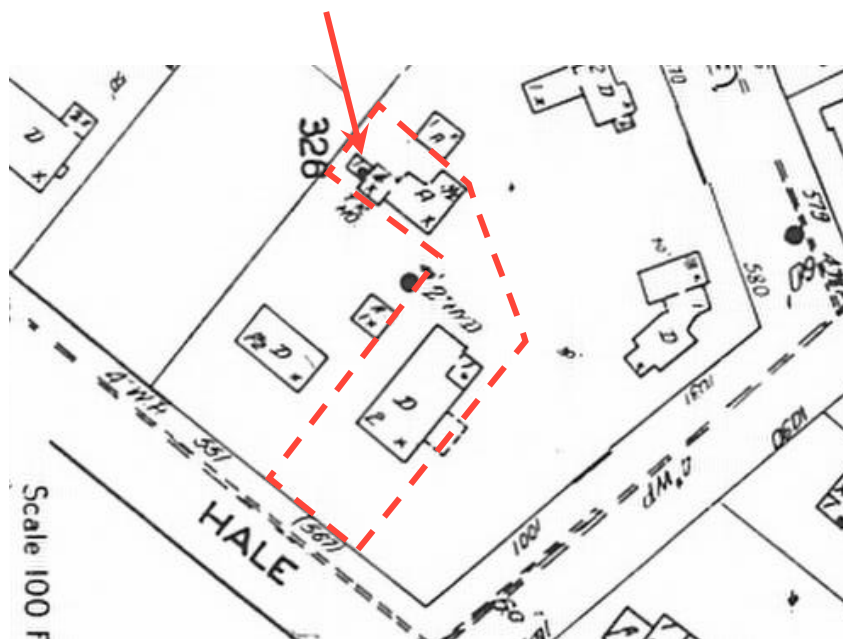
Figure 26: A 1947 Sanborn Map of 567 Hale Street. Current property line is shown in dashed red line. A red arrow shows the location of the tankhouse. Source: Fire Insurance Maps Online. Edited by Page & Turnbull.

**(Figure 26).** In 1929, the barn was repurposed as an automobile garage. Between 1935 and 1966, the tankhouse and grape arbor were demolished, the entry porch was enclosed, entry steps were modified, and the lot was subdivided in a manner that created an L-shaped lot at the corner of Hale Street and Hamilton Avenue. The lot was subdivided again in 1966, eliminating access to Hamilton Avenue, further increasing the density of the infill development of the block.

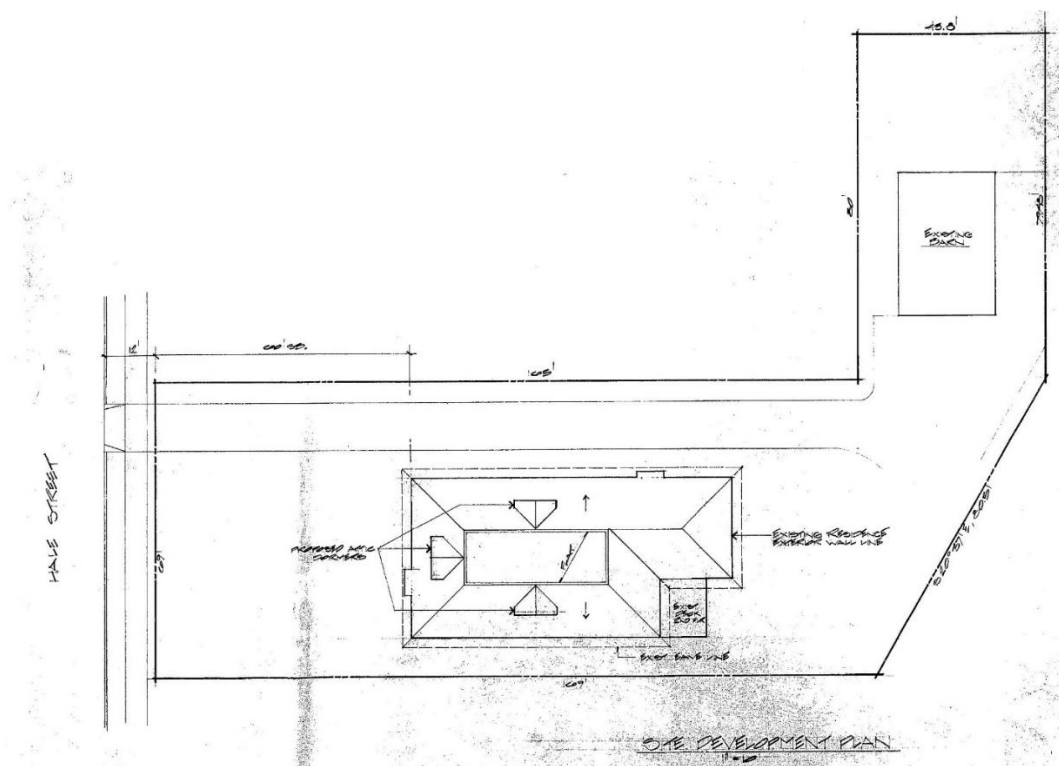
Figure 27: 1990 Site plan for 597 Hale Street. Primary façade (facing Hale Street) at left. Source: Source: drawings by Thomas Whitford Design, on file at Palo Alto Development Services.

In 1990, a new series of modifications were made to the property. Owners Mr. and Mrs. Anker remodeled the attic of the primary residence by adding three dormers to the roof, two on the northwest and southeast eaves and one on the primary (southwest) eave (**Figure 27 and Figure 28**) (The dormer over the primary façade has since been removed). In 1995, the Ankers added the steps, gabled dormer roof and deck to the rear (northwest) façade of the garage (**Figure 29**).

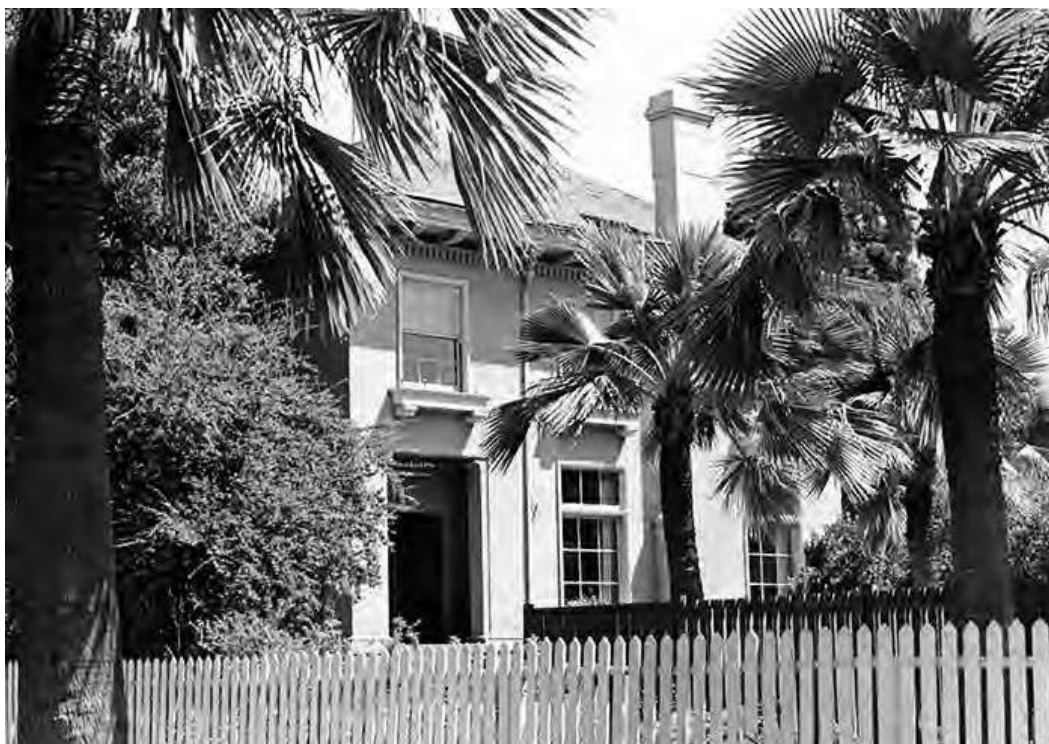
Figure 30: Undated photo of 567 Hale Street. Source: Palo Alto Historical Association.
