# The Residences at Matadero Creek

RESIDENTIAL AND RETAIL

Palo Alto, 3400 El Camino Real

THE RESIDENCES AT MATADERO CREEK IS A WORKING NAME FOR A PLANNED HOUSING ZONE (PHZ) REDEVELOPMENT OF THE PROPERTY AT 3400 EL CAMINO REAL, PALO ALTO THAT WOULD CREATE 382 RESIDENTIAL RENTAL UNITS COMPRISED OF 44 STUDIOS, 243 ONE-BEDROOM, 86 TWO-BEDROOM AND 9 THREE-BEDROOM UNITS IN TWO BUILDINGS.

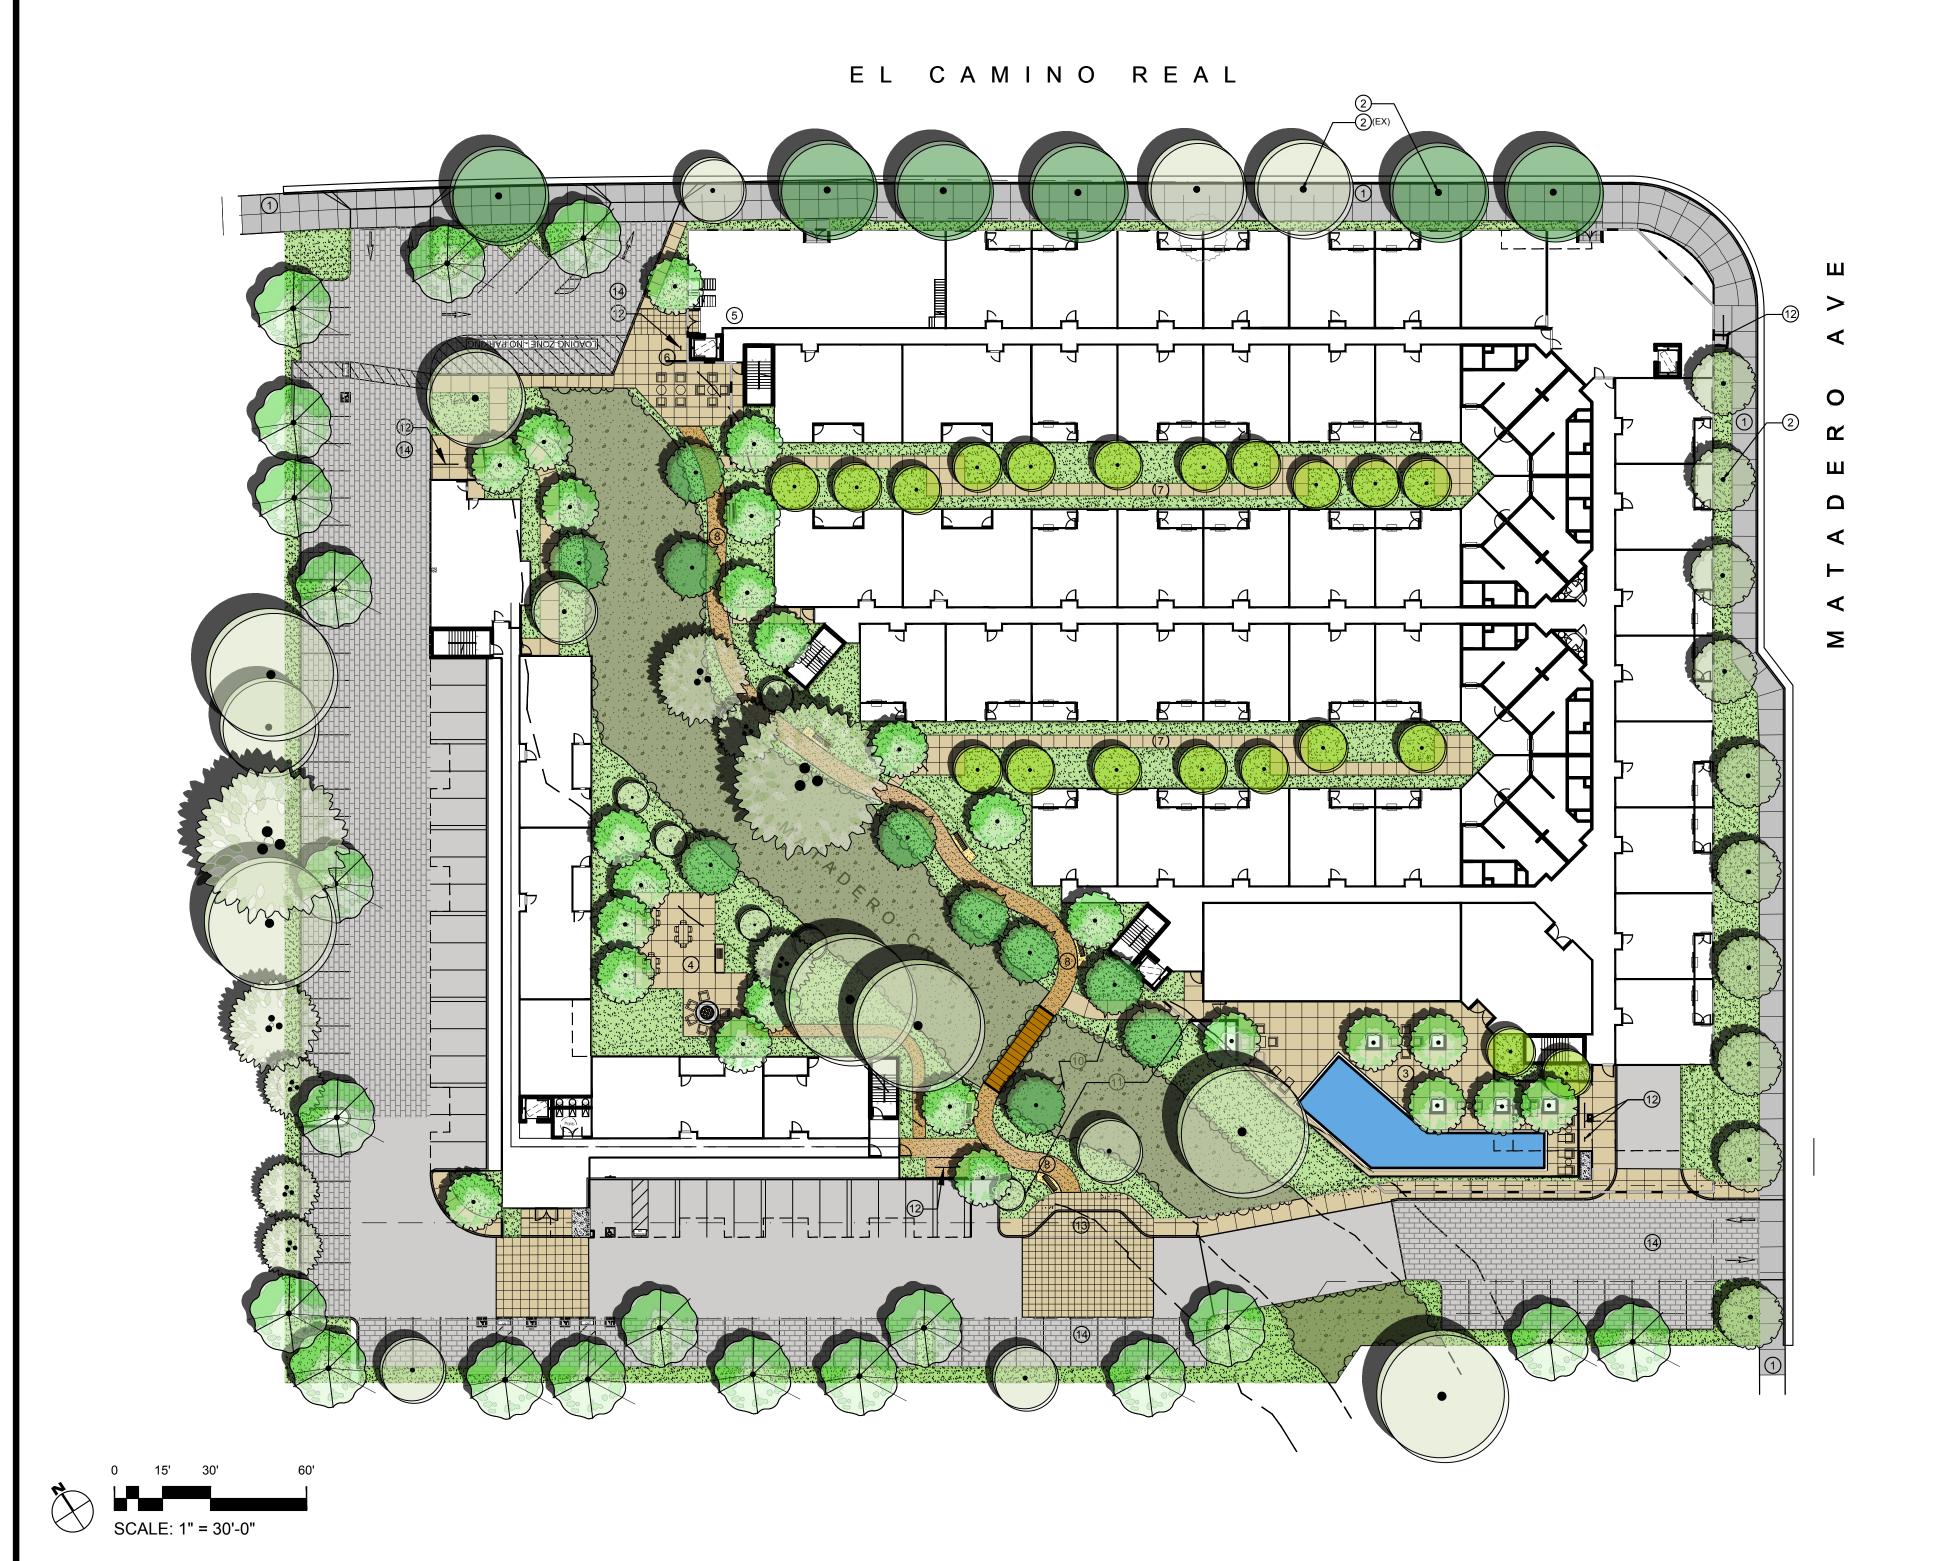
LANDSCAPE PLAN

- 1 CITY SIDEWALK 12 FT WIDE ON EL CAMINO REAL 8 FT WIDE ON MATADERO AVENUE
- 2 STREET TREES
- 3 POOL RECREATION AREA FOR PROJECT RESIDENTS
- 4 RECREATION AREA FOR PROJECT RESIDENTS
- 5 RETAIL SPACE
- 6 OUTDOOR SPACE AT RETAIL SPACE
- 7 COURTYARD
- (8) TRAIL (DECOMPOSED GRANITE)
- 9 PEDESTRIAN BRIDGE
- 10) TOP OF BANK (MATADERO CREEK)
- (11) 20 FT SETBACK FROM TOP OF BANK (MATADERO CREEK)
- 12) BIKE RACK (SHORT TERM STORAGE)
  39 SPACES FOR RESIDENTIAL USE
  3 SPACES FOR RETAIL USE
- 13 DROP OFF ZONE
- (14) PERVIOUS PAVEMENT (REFER TO CIVIL PLAN)
