The Residences at Matadero Creek

RESIDENTIAL AND RETAIL

Palo Alto, 3400 El Camino Real

LOCATION MAP SCOPE OF WORK THE RESIDENCES AT MATADERO CREEK IS A WORKING NAME FOR A PLANNED HOUSING ZONE (PHZ) REDEVELOPMENT OF THE PROPERTY AT 3400 EL CAMINO REAL, PALO ALTO THAT WOULD CREATE 382 RESIDENTIAL RENTAL UNITS COMPRISED OF 44 STUDIOS, 243 ONE-BEDROOM, 86 TWO-BEDROOM AND 9 THREE-BEDROOM UNITS IN TWO BUILDINGS.

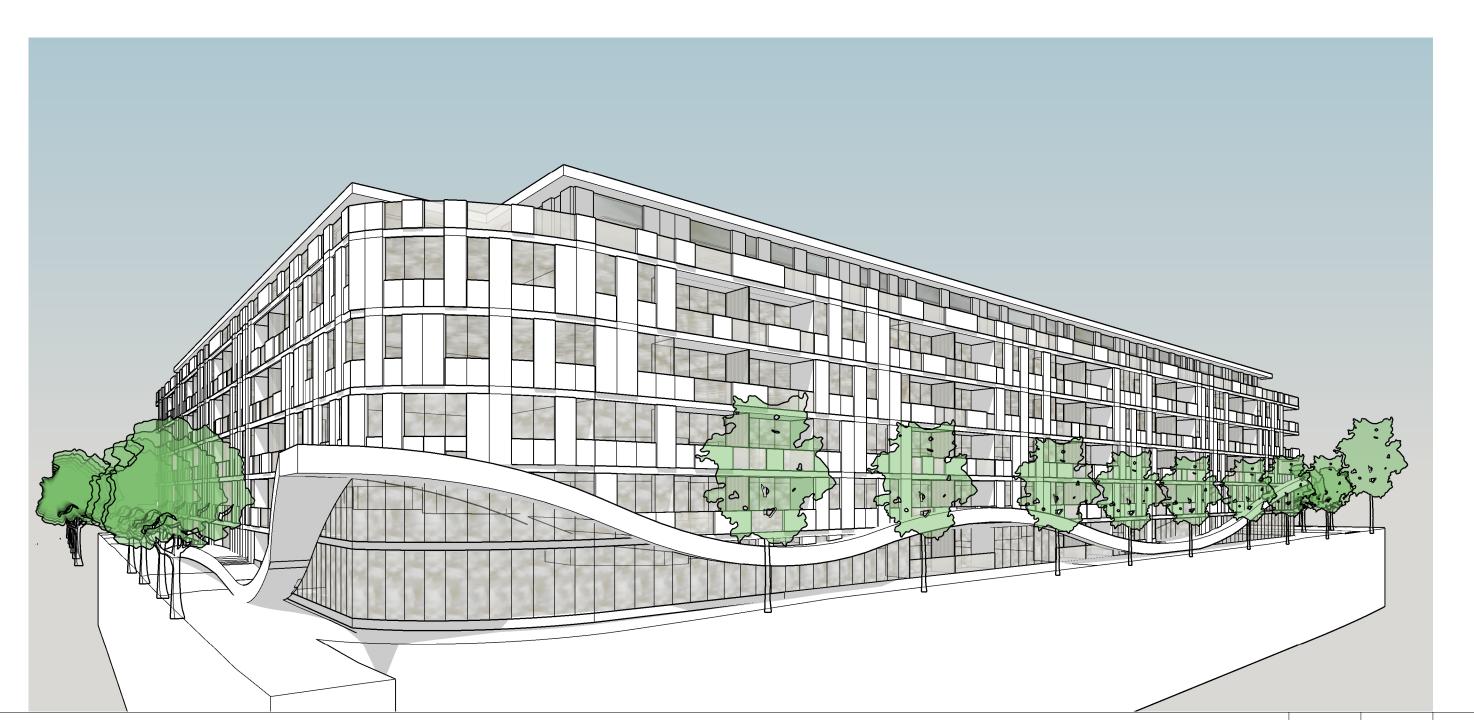
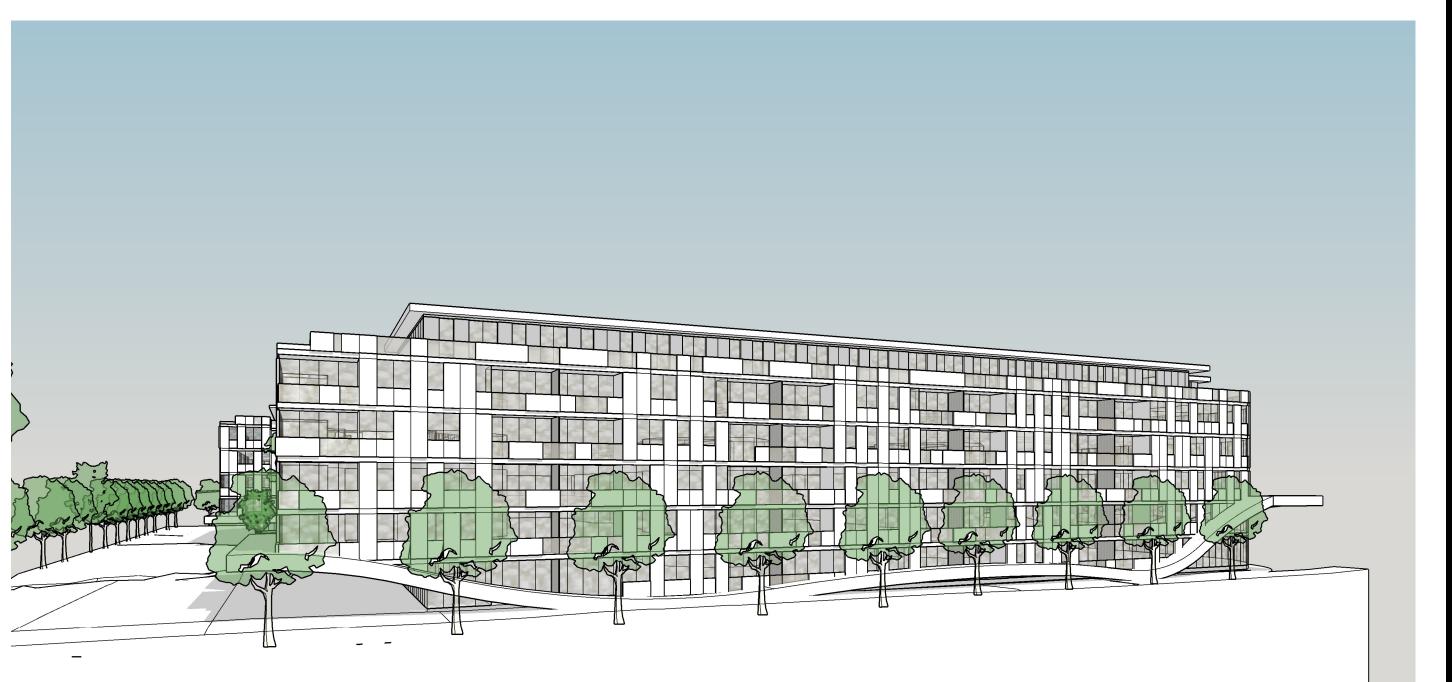
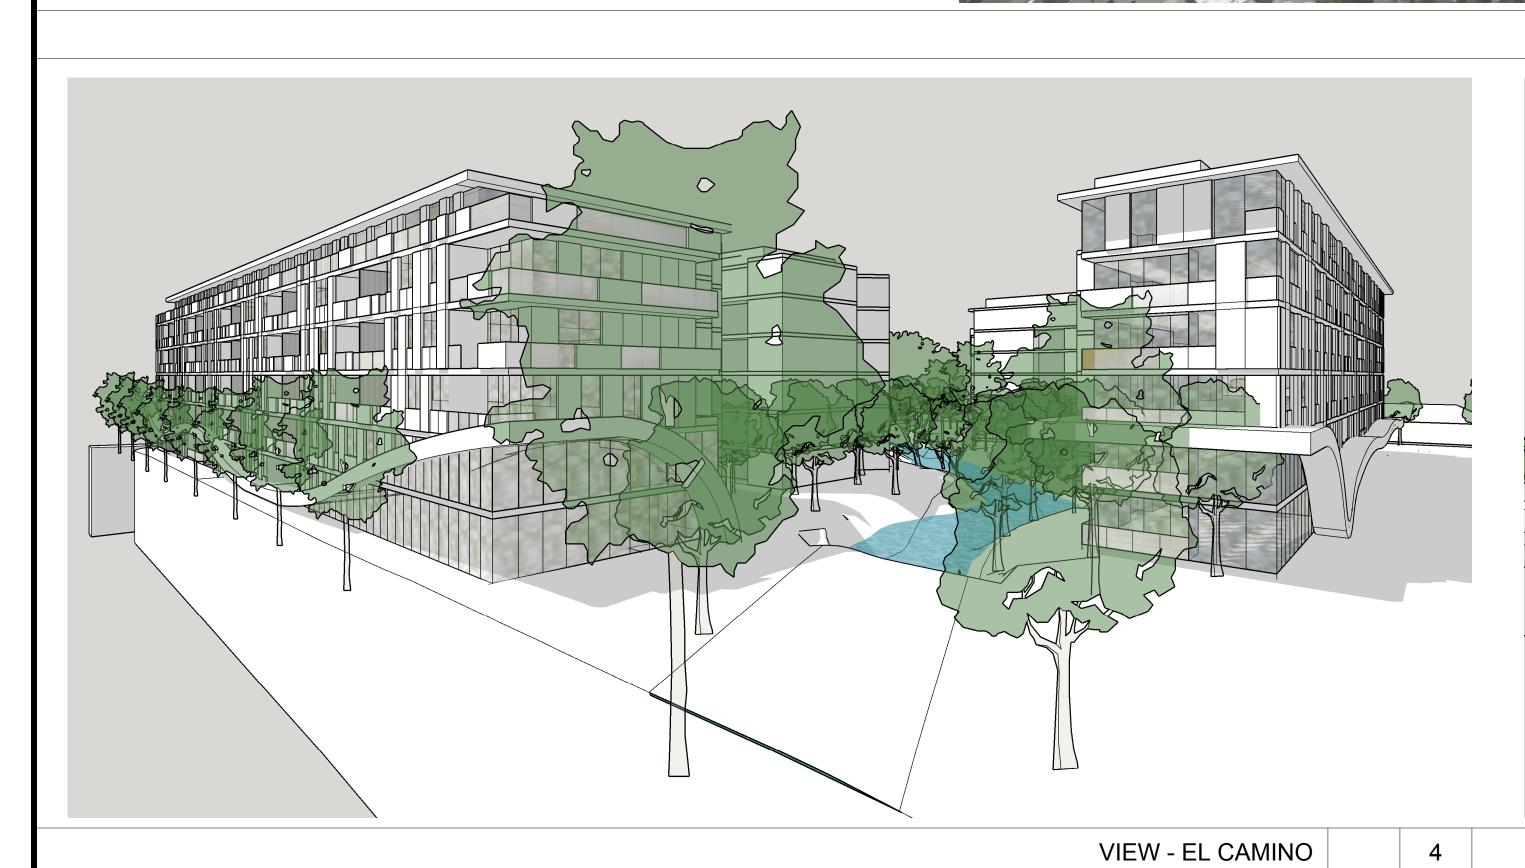
STREETVIEW PERSPECTIVES

VIEW - EL CAMINO REAL LOOKING DOWN TO MATADERO AVE

VIEW - MATADERO AVE

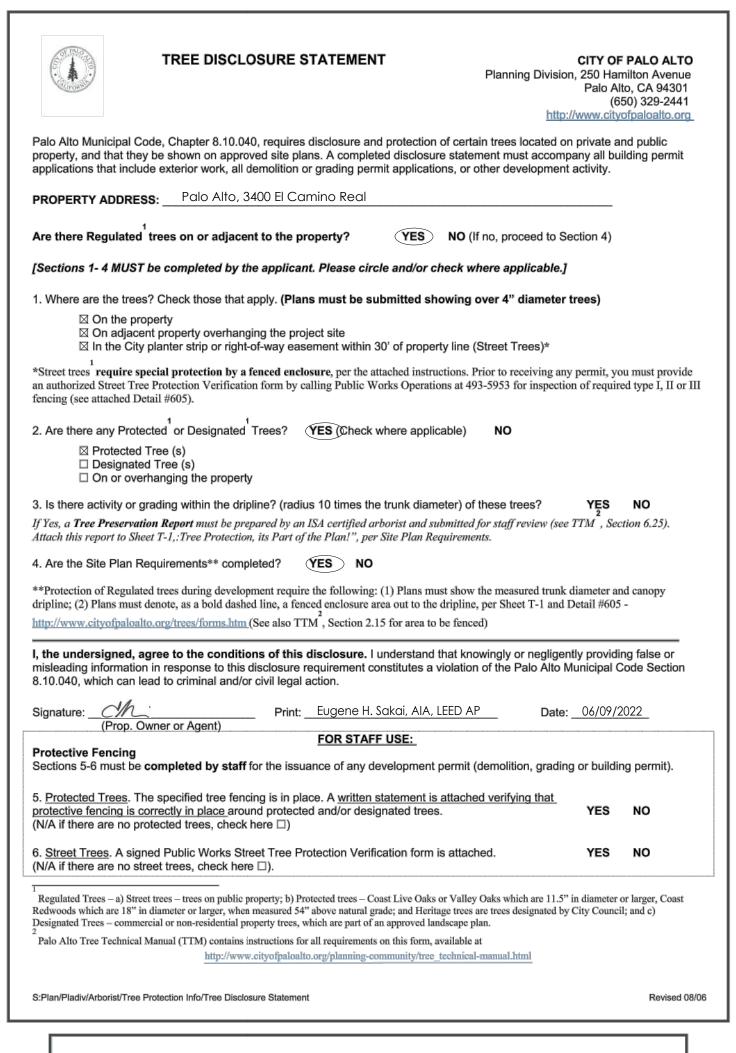
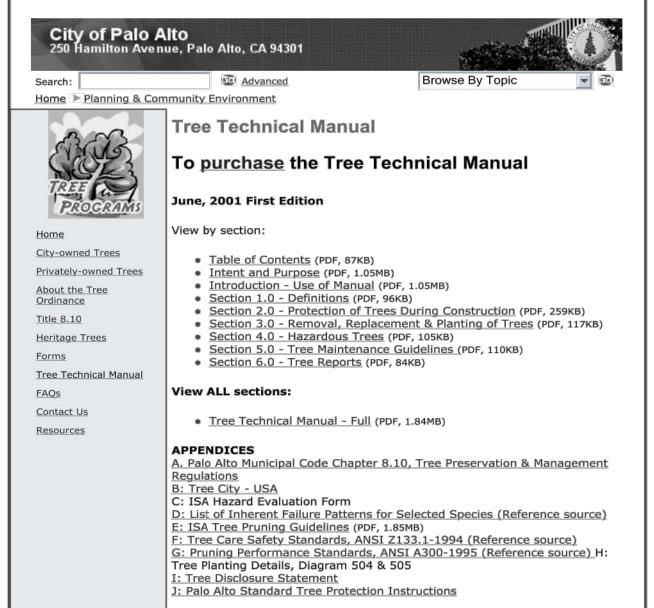
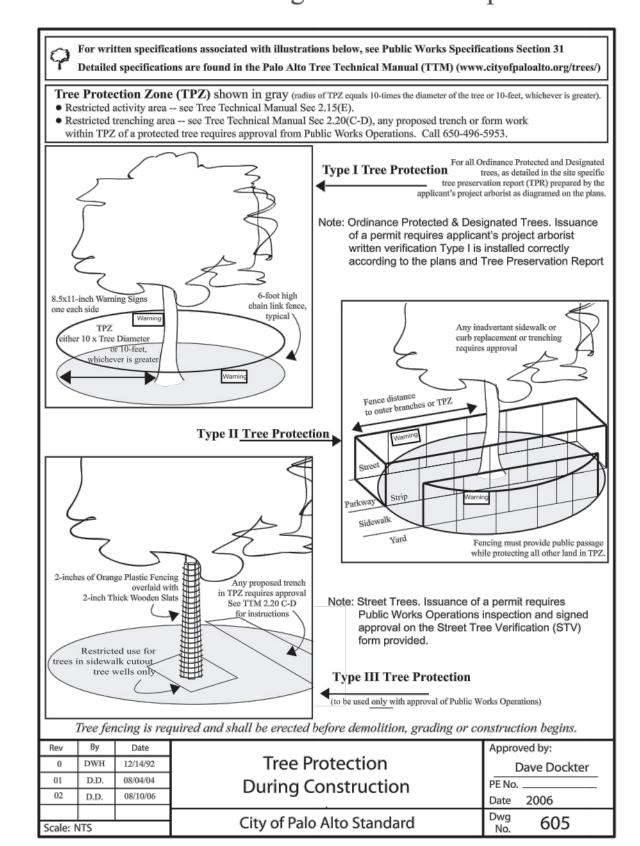
Fenced enclosures around trees are essential to protect them by keeping the foliage canopy and branching structure clear from contact by equipment, materials and activities, preserving roots and soil conditions in an intact and non-compacted state, and identifying the Tree Protection Zone (TPZ) in which no soil disturbance is permitted and activities are restricted, unless otherwise approved. An approved tree protection report must be added to this sheet when project activity occurs within the TPZ of a regulated tree.

100	A .	PALO ALTO STREET TREE PROTECTION INSTRUCTIONSSECTION 31
31-1	Genera	
	a,	Tree protection has three primary functions, 1) to keep the foliage canopy and branching structure clea from contact by equipment, materials and activities; 2) to preserve roots and soil conditions in an intact an non-compacted state and 3) to identify the Tree Protection Zone (TPZ) in which no soil disturbance i permitted and activities are restricted, unless otherwise approved.

b.	The Tree Protection Zone (TPZ) is a restricted area around the base of the tree with a radius of ten-time the diameter of the tree's trunk or ten feet; whichever is greater, enclosed by fencing.
31-2	Referen	nce Documents

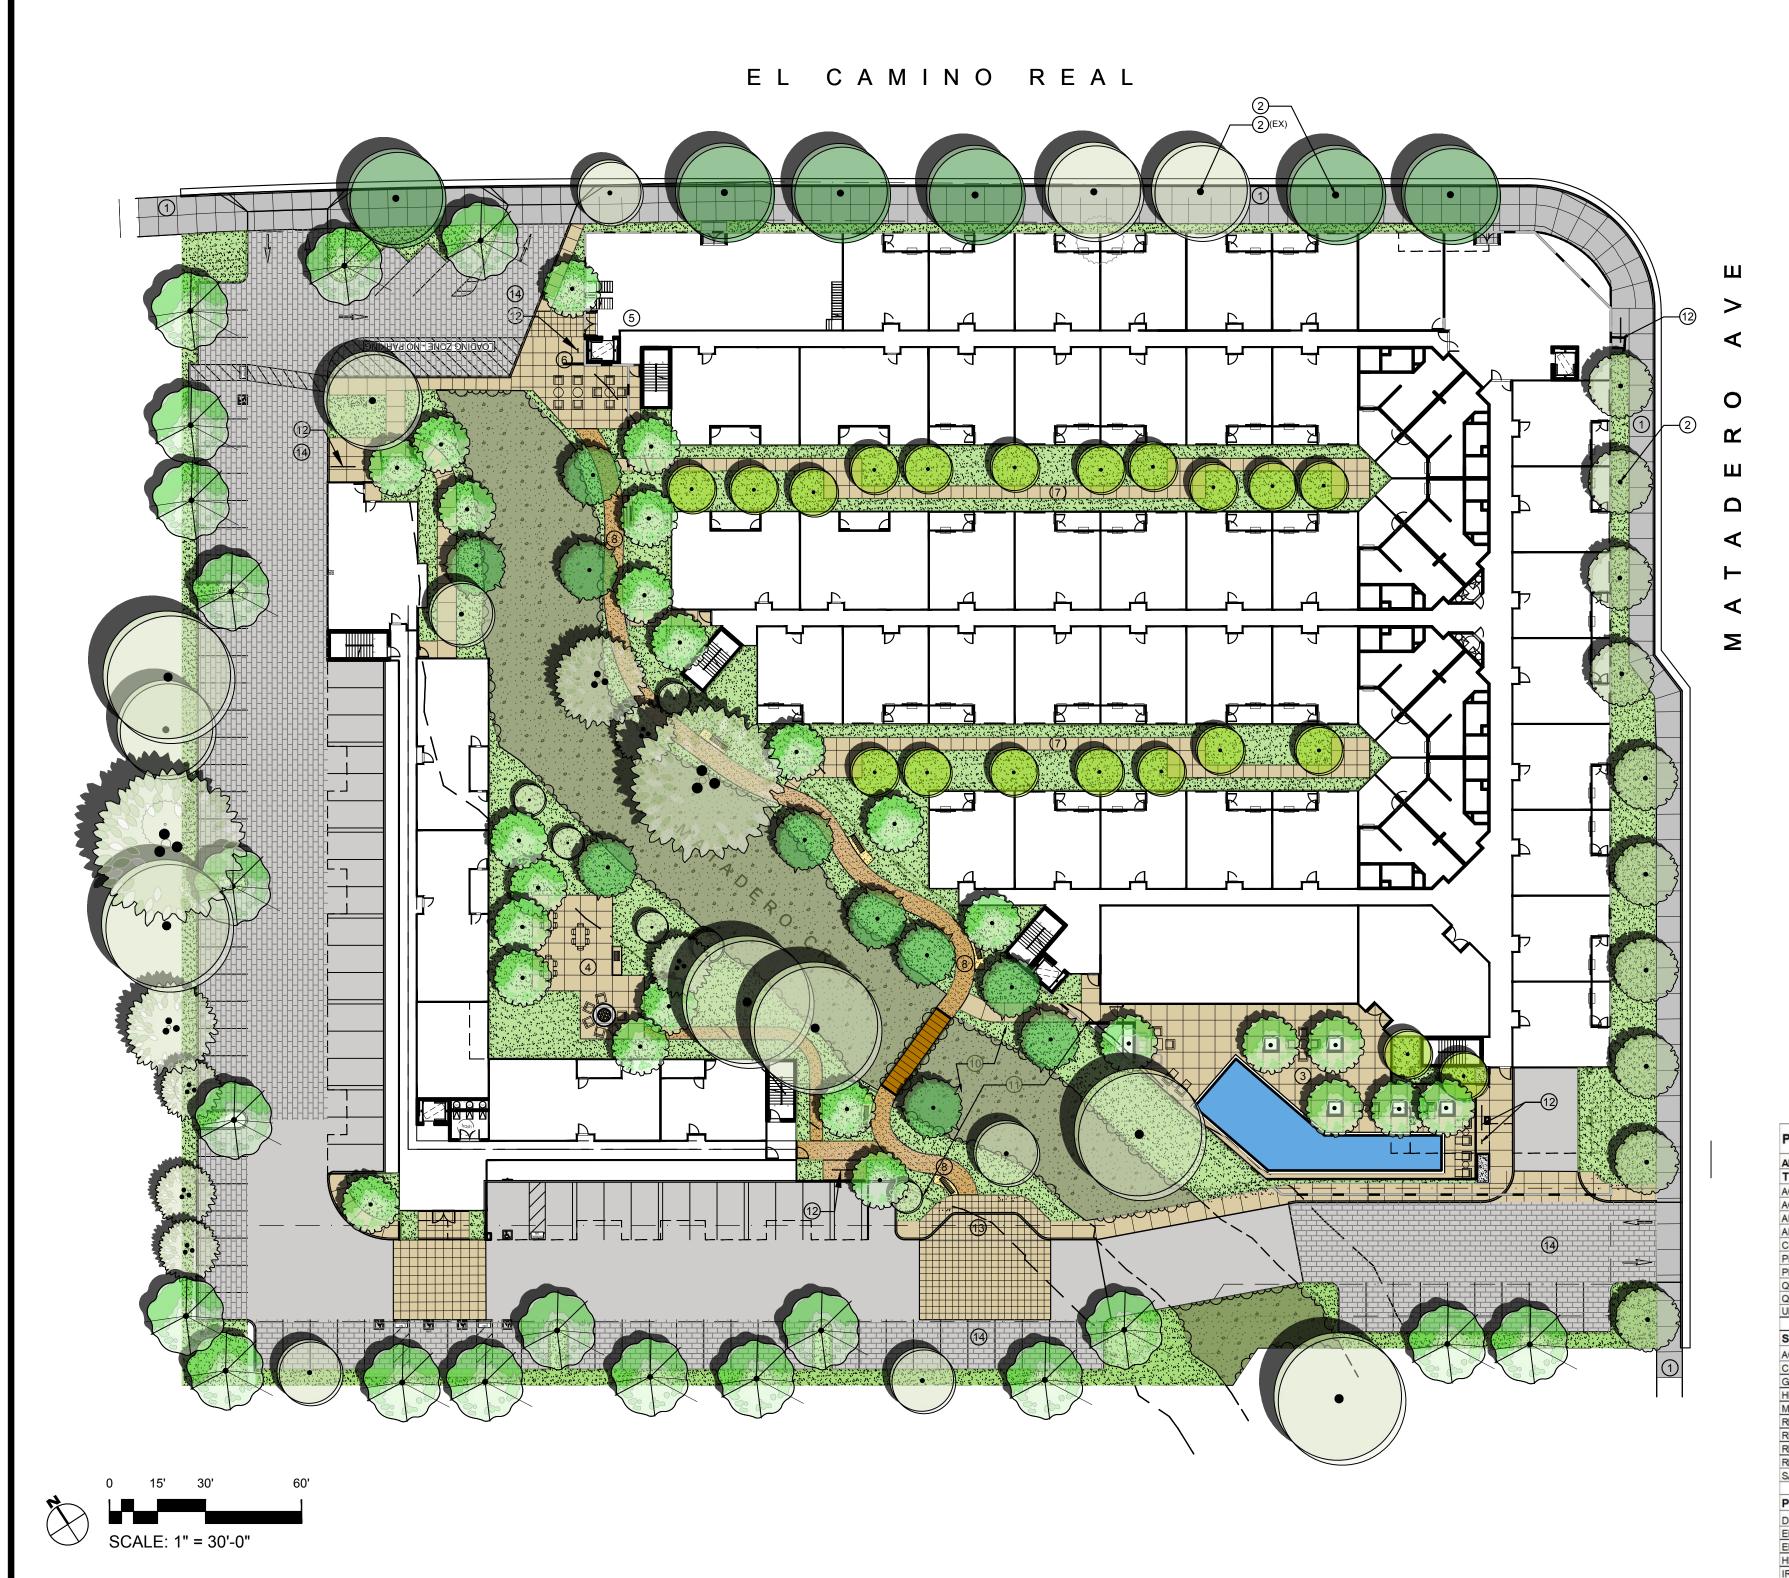
GRADING AND DRAINAGE PLAN

- 1 CITY SIDEWALK
 12 FT WIDE ON EL CAMINO REAL
 8 FT WIDE ON MATADERO AVENUE
- 2 STREET TREES
- 3 POOL RECREATION AREA FOR PROJECT RESIDENTS
- 4 RECREATION AREA FOR PROJECT RESIDENTS
- 5 RETAIL SPACE
- 6 OUTDOOR SPACE AT RETAIL SPACE
- 7 COURTYARD
- 8 TRAIL (DECOMPOSED GRANITE)
- 9 PEDESTRIAN BRIDGE
- 10 TOP OF BANK (MATADERO CREEK)
- (11) 20 FT SETBACK FROM TOP OF BANK (MATADERO CREEK)
- 12 BIKE RACK (SHORT TERM STORAGE)
 39 SPACES FOR RESIDENTIAL USE
 3 SPACES FOR RETAIL USE
- 13) DROP OFF ZONE
- (14) PERVIOUS PAVEMENT (REFER TO CIVIL PLAN)
