**PUBLIC ARTWORK ASSESSMENT
PALO ALTO, CALIFORNIA**

Condition Assessment and Recommendations for Selected Artworks

Prepared for:
City of Palo Alto

Prepared by:
ARG Conservation Services, Inc.
San Francisco, California

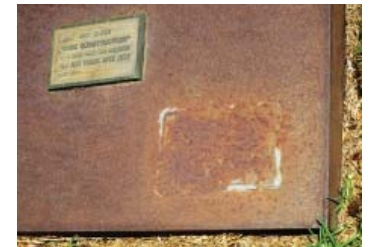
- Small nicks/ abrasions at edges, most likely related to lawn care.
- Base sits within a depression; potential for corrosion from ground water collection and further damage during lawn care.
- Signage plaque was relocated; residue from prior adhesive (epoxy?) at original location.

Detail of plaque at base. Note adhesive residue at original location.

- Regrade site surrounding sculpture so that ground slopes away from base. Install a mow strip of crushed stone or other material to prohibit lawn growth and provide a buffer strip to prevent future damage from lawn care.

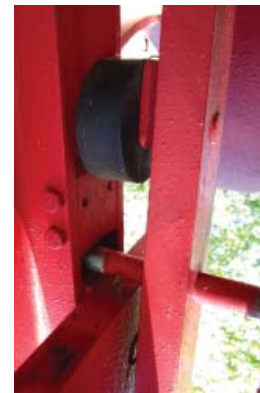
- Stable structural condition; kinetic components move with ease.
- Red paint coating appears stable, has spray texture when viewed up close. Very minimal fading from UV exposure.
- Overall soiling, debris, and insect nests/cobwebs throughout, heavier accumulations at sky-facing surfaces of tower and rings, and near base.
- Rubber components exhibit minor bio-growth.
- Paint loss at metal components at rotation point.

Detail of rubber stop and paint loss at pivot point.

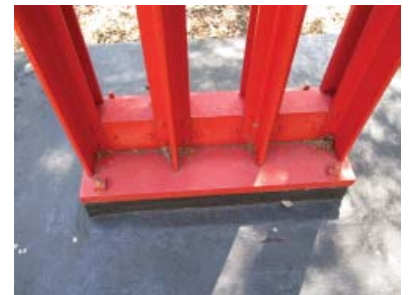
Detail of anchorage to plinth. Note soiling/ debris.

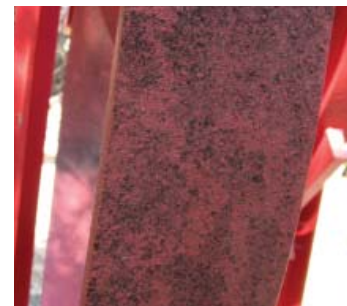
Detail of soiling at sky-facing surface of ring.

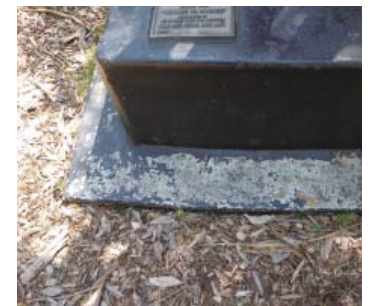
- Heavy paint loss throughout, particularly at concrete pad. Paint is slightly chalked/ faded.
- Hairline and fine-width cracks at each side near center.
- Overall soiling and debris at concrete surfaces.

Detail of paint loss at the concrete pad.

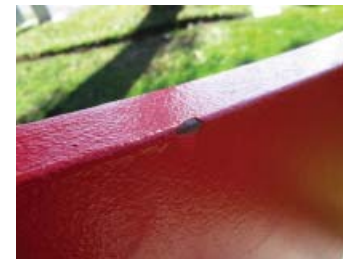
Detail of paint loss at front edge.

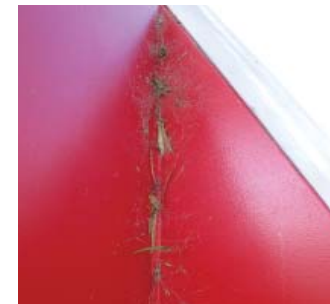
Detail of debris and insect nests at vertical joint.

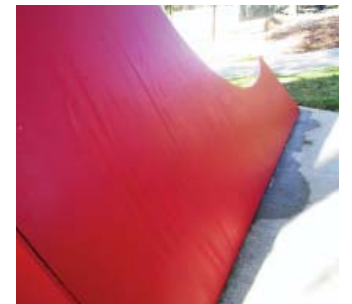
Detail of marks/surface marring on reverse.

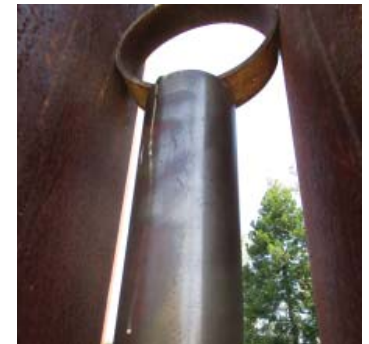
Detail of patina loss and soiling at gilded tube.

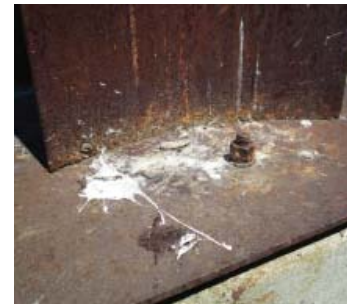
Detail of guano accumulated at metal base.

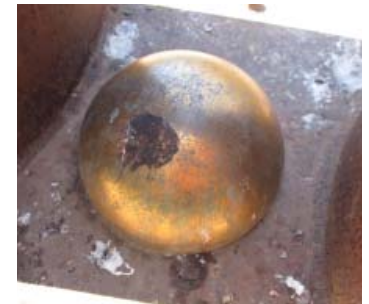
Detail of patina loss at half sphere element.

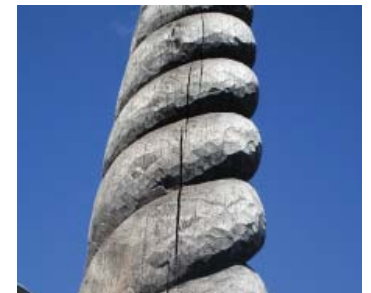
Detail of carved spiral. Note checking in wood.

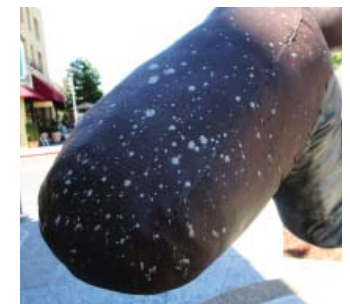
Detail of concrete splatter at doll's proper left foot.

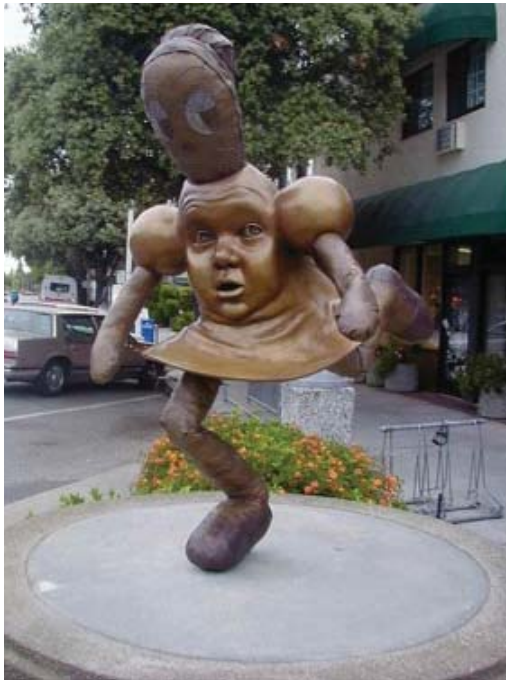
Photo courtesy artist's website. Note overall bright golden patina color at doll's face and dress. Also note differences in paint color at doll's face (duller/more subtle hues), and lack of inscriptions or leaf ornament at base. Photo taken in process of installation? Was the face repainted?

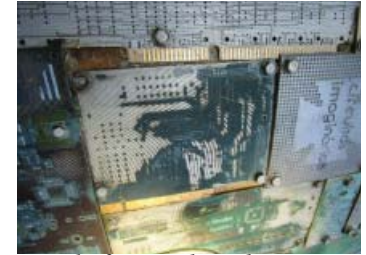
Detail of circuit boards. Note heavy color shift/ fade.

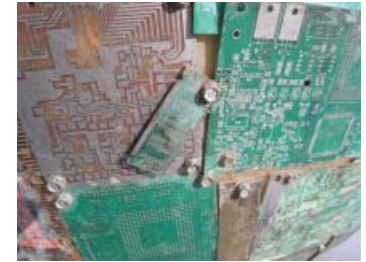
Detail of possible dislodged/ rotated circuit board.

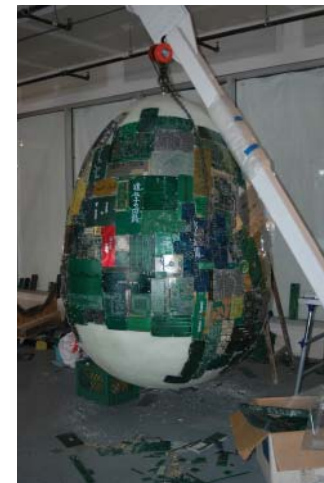
Sculpture in process. Note significant color difference. Photo courtesy artist's website.

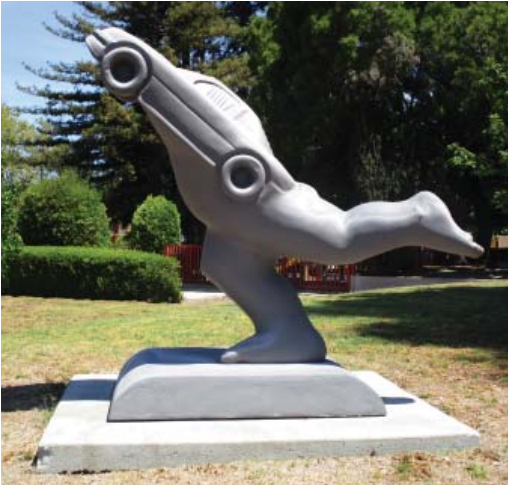
Title: *Rrrun*

- Stable structural condition.
- Crack in fiberglass base near toes.
- Crack in fiberglass base at proper left side.
- Photochemical degradation of fiberglass surfaces, including discoloration, fading, chalking, and tide line effects. Particularly visible at top of outstretched leg and hood of car.
- Overall atmospheric soiling throughout; bird guano drops at top of car.
- Gold paint splatter at fiberglass base.

- Clean all surfaces with a pH neutral conservation-grade detergent.
- Repair cracks in fiberglass with compatible epoxy filler, based on conservator testing
- Consider and test effectiveness of repainting (either in localized areas or in entirety).
- Consider and test effectiveness of a clear penetrating water repellent with UV stabilizers.
- Monitor test areas for extended period prior to any application of larger treatment. Consult the artist.

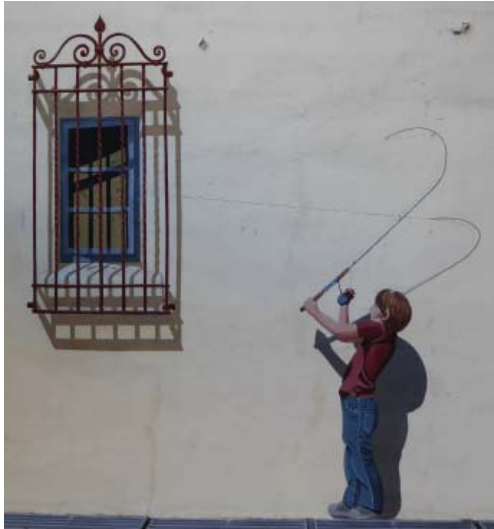
Title: *Boy Fishing*

- Overall poor condition.
- Cracking and flaking of paint throughout, including artist-painted surface and paint coating at stucco.
- Repainted, reportedly by artist. Earlier scheme still visible below in loss areas. Earlier paint is lighter, faded with UV degradation.
- Artist may have changed the color scheme in the over-paint; green color noted at losses at boy's blue jeans.
- Glossy finish or coating observed in localized areas of loss, suggesting earlier version may have been sealed prior to repainting.
- Wall surfaces are soiled throughout, water stains visible.

- Located in a secluded area of the site, partially obscured by tree. Metal grates for below-grade areaway immediately adjacent.
- Conditions at building roof, wall, and drainage system contributing to deterioration of mural.
- No spotlight observed nearby.
- Sprinkler near but aimed away from wall.

- Repair existing building roof and drainage system prior to any conservation treatments.

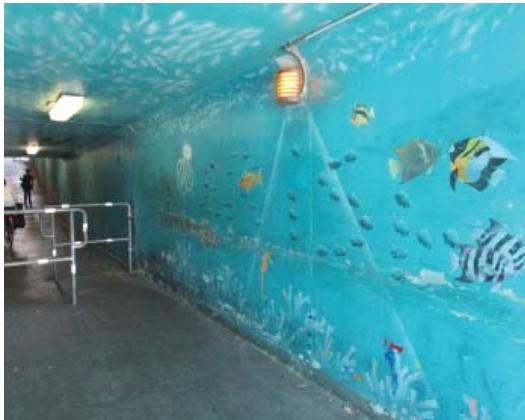
Title: *Year of the Ocean*

- Painted surfaces have soiling, stains and grime.
- Multiple areas of paint loss, including flaking paint and abrasions from traffic.
- Earlier paint scheme or graffiti noted below mural at tunnel walls near ground.
- Localized areas of overpainting, including repairs to some of the figures, and obliteration of others.
- Painted surfaces at portions of exterior walls much lighter in color, possible UV degradation.
- Damaged and missing grille covers.
- Damage and overpainting at railings.
- Missing backer rod and sealant at expansion joints.

- Consult the artist regarding methods and materials used, and possible involvement in restoration work.
- Stabilize and consolidate flaking paint with appropriate adhesive based on conservator testing.
- Perform overall dry cleaning with conservation sponges, and localized wet cleaning with pH neutral conservation-grade detergent and/or solvents to remove stubborn stains.
- Coat loss areas with a reversible barrier resin to encapsulate and protect original artwork.
- In-paint to visually integrate losses, preferably by artist.
- Consider and test effectiveness of clear water repellent with UV stabilizers.
- Perform crack repairs and spall repairs at concrete walls prior to mural work.
- Install new backer rod and sealant at expansion joints.
- Replace damaged or missing grilles with similar manufacturer's stock design.
- Clean and repair existing railings to remain.

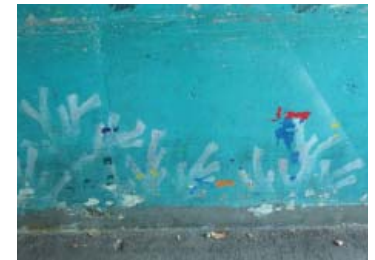
Detail of soiling and flaking at tunnel. Note primary colors below.

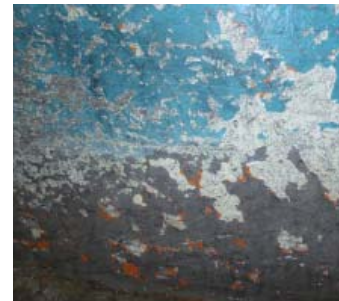
Detail of soiling and flaking paint near ground at tunnel.

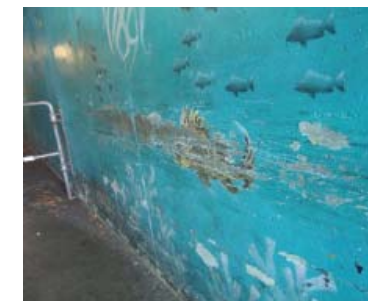
Detail of paint loss/ abrasion at tunnel walls.
